APPENDIX C

**TECHNICAL LAND INFORMATION
 FACT SHEETS**
 Area-wide Suburbs

Factsheet 15 - Tai Tapu to Halswell

Halswell River, Lincoln and Tai Tapu

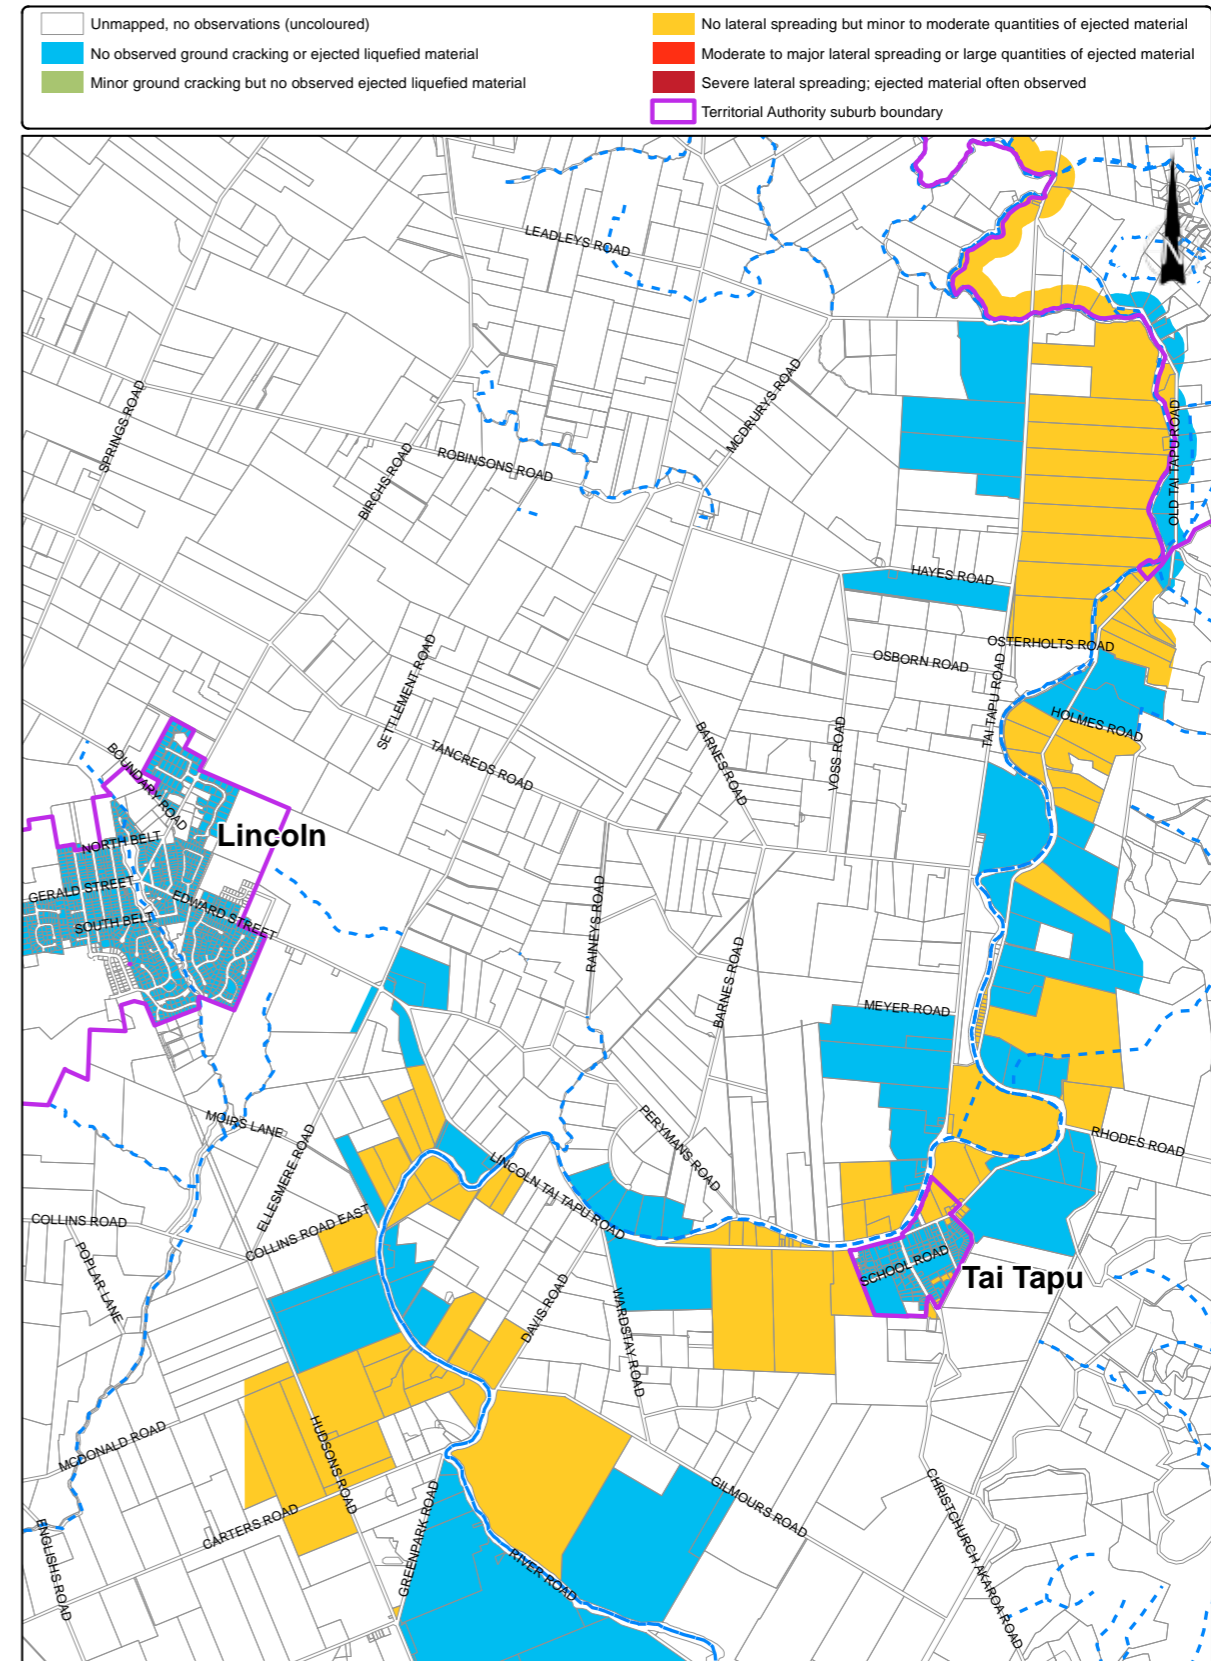
Figure C15.1 and **Table C15.3** present a summary of the property-by-property rapid mapping of liquefaction and lateral spread observations undertaken by EQC in this area. The mapping undertaken by EQC was predominantly of the main urban areas of Lincoln and Tai Tapu, with less detail in the surrounding rural areas. For more extensive and detailed mapping of liquefaction observations in these rural areas, refer to the post-earthquake liquefaction report commissioned by the Selwyn District Council, available at <http://www.selwyn.govt.nz/services/building/earthquake-building-recovery/liquefaction-report>. These observed liquefaction and lateral spread mapping colours have completely different meaning to the colour codes used by the Canterbury Earthquake Recovery Authority (Cera) for residential land zoning and the Department of Building and Housing (DBH) for technical categories.

Suburb	Observations
Halswell River	Minor to moderate liquefaction in many rural areas alongside the Halswell River and other watercourses, causing sand ejection and settlement. Minor lateral spreading in some localised areas alongside the Halswell River. For the remainder of the area, no surface evidence of liquefaction or related land effects was observed.
Lincoln	No surface evidence of liquefaction or related land effects observed.
Tai Tapu	Minor to moderate liquefaction in several small areas, causing sand ejection and settlement. For the remainder of the urban area, no surface evidence of liquefaction or related land effects was observed.

Figure C15.1 - Overview of liquefaction and lateral spreading observations, from mapping undertaken following the earthquake of 4 September 2010.
