An Analysis of Tsunami Impacts to Lifelines

N.A. Horspool S. Fraser

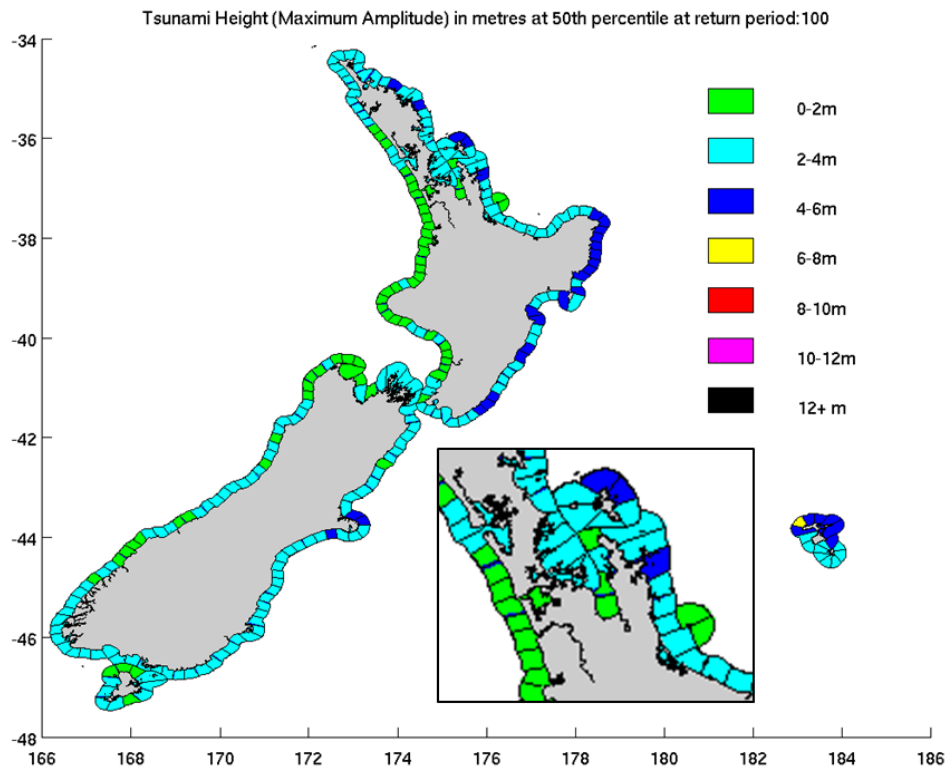
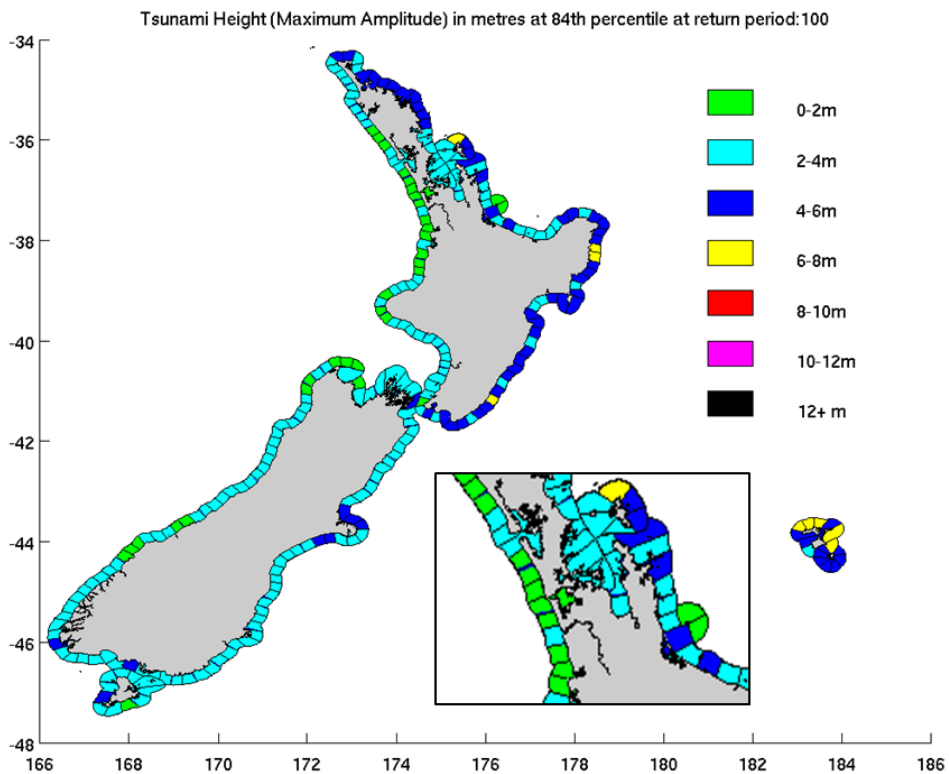
Figure 1 Expected maximum tsunami height in metres at 100 year return period, shown at median (50th percentile) and 84th percentile of epistemic uncertainty. Source: Power (2013).

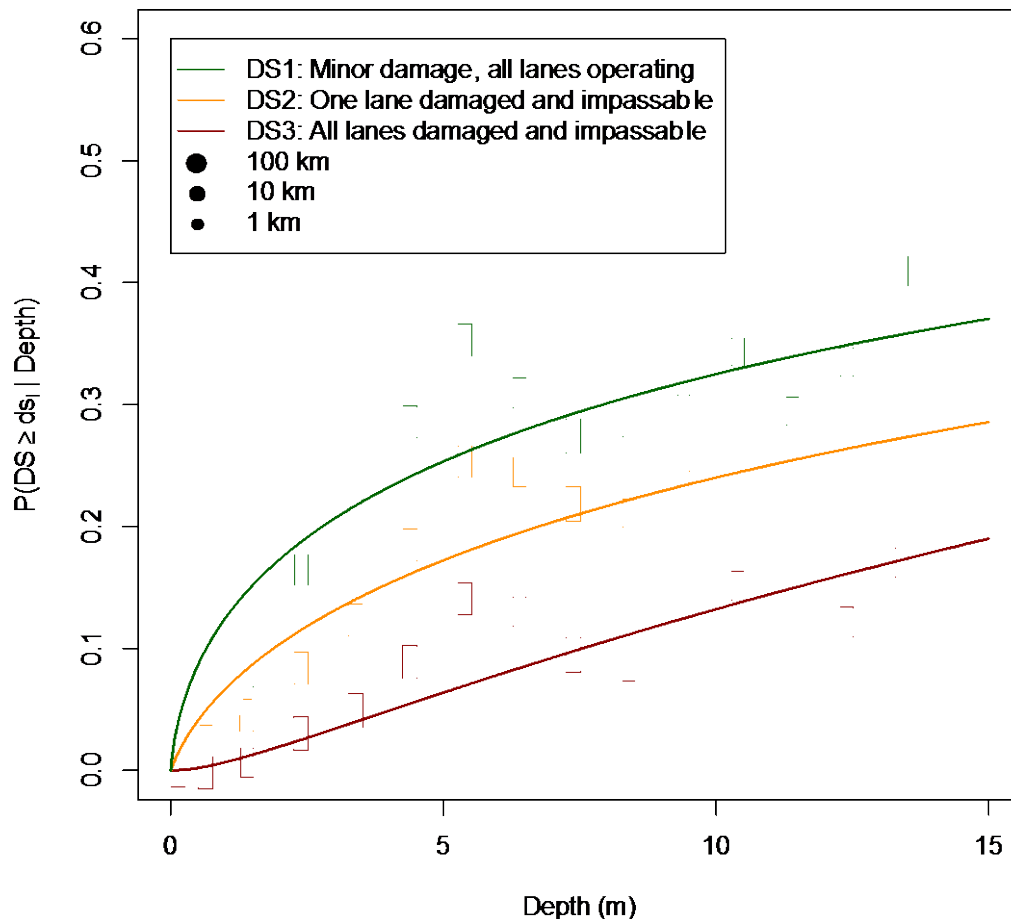
Figure 5 Fragility curve for roads, based on MLIT (2012) data from Miyagi and Iwate Prefecture. Each curve defines the probability of being in that damage state or greater as a function of tsunami inundation depth (m). For example at 5m flow depth there is a 65% probability of no damage, 25% probability of experiencing at least Damage State 1, 17% probability of experiencing Damage State 2 or greater, and a 5% probability of experiencing Damage State 3. The size of the data points indicates the length of road at that depth and damage state level in the database. See Appendix 1 for details on how the fragility curves were developed.

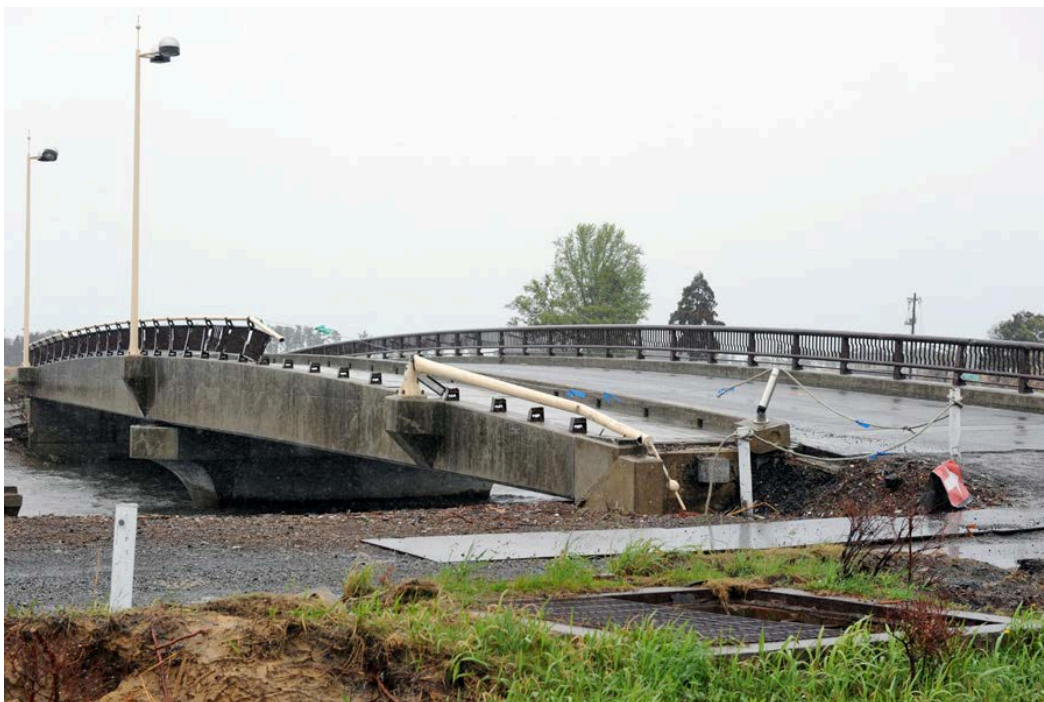
Figure 9 Bridge in Japan with minor-moderate damage of the superstructure and some minor scouring in the foreground. Source: Structural Engineers Association of Washington.

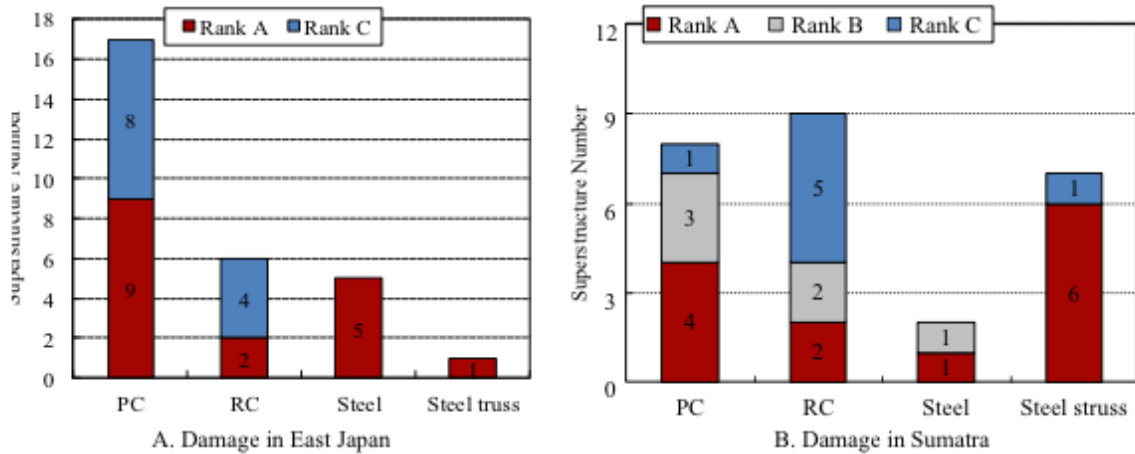
Figure 11 Damage data for different bridge types in Japan (A) and Sumatra (B). Rank A is complete destruction of superstructure, Rank B is where the superstructure has moved but not been washed away, and Rank C is minor or no damage. PC = precast concrete, RC=reinforced concrete. Note that this data does not show the damage rank (class) as a function of tsunami flow depths. The numbers on the bars indicate the number of bridges in each damage rank. Note that Rank A = Damage State 3, Rank B = Damage State 2 and Rank C = Damage State 1.

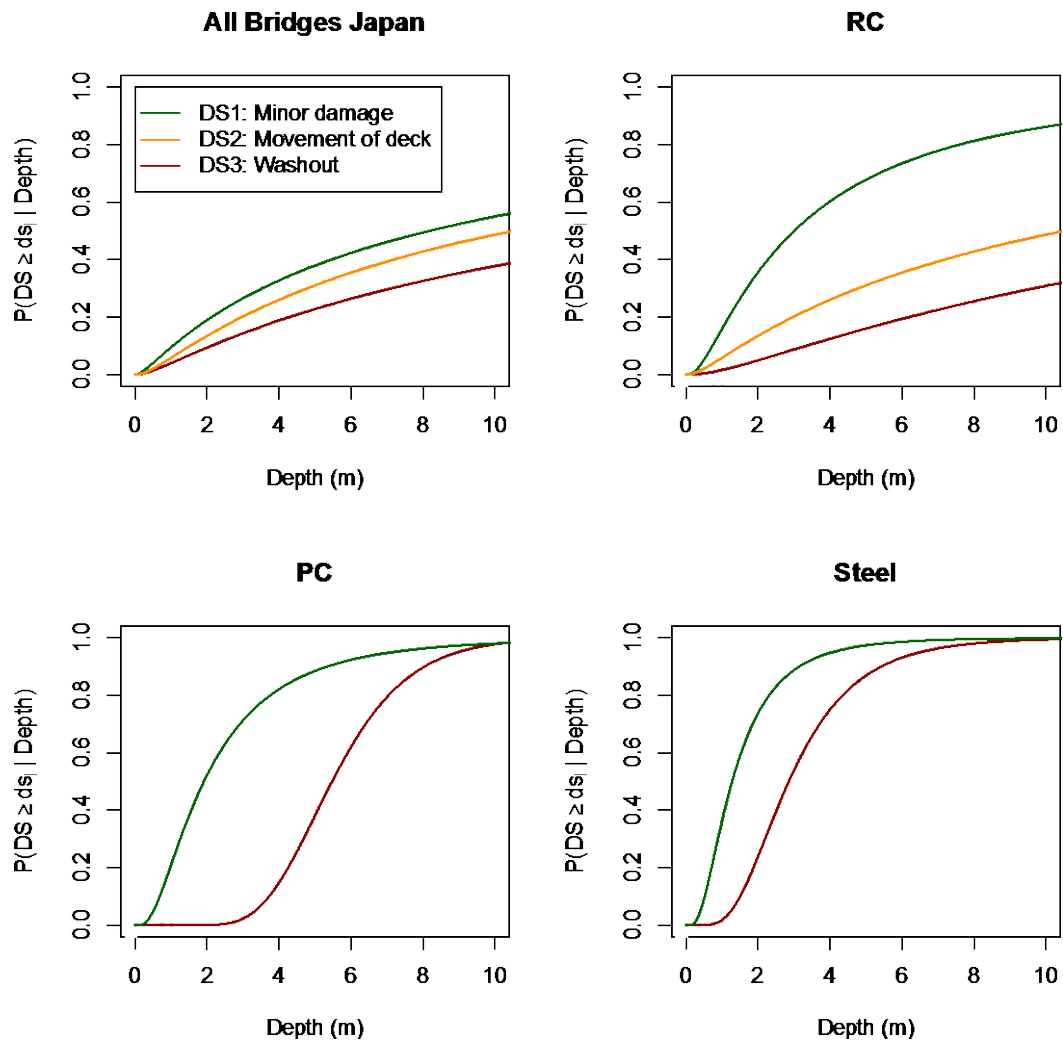
Figure 12 Fragility curve for bridges, based on MLIT (2012) data from the 2011 Japan Tsunami in Miyagi and Iwate Prefectures and the 2004 Indian Ocean Tsunami in Sri Lanka and Indonesia from Shoji (2007). Each curve defines the probability of being in that damage state or greater as a function of tsunami inundation depth (m) above the base of the bridge deck. See Appendix 1 for details on how the fragility curves were developed. Upper Left Panel: All bridge data from the 2011 Japan Tsunami (note the data did not detail bridge construction type), Upper Right Panel: Reinforced Concrete bridge data from the 2004 Indian Ocean Tsunami, Lower Left Panel: Precast Concrete from the 2004 Indian Ocean Tsunami, Lower Right Panel: Steel bridges from the 2004 Indian Ocean Tsunami. Note that for PC and Steel bridges there was not enough data at Damage State 2 to be included in the analysis.

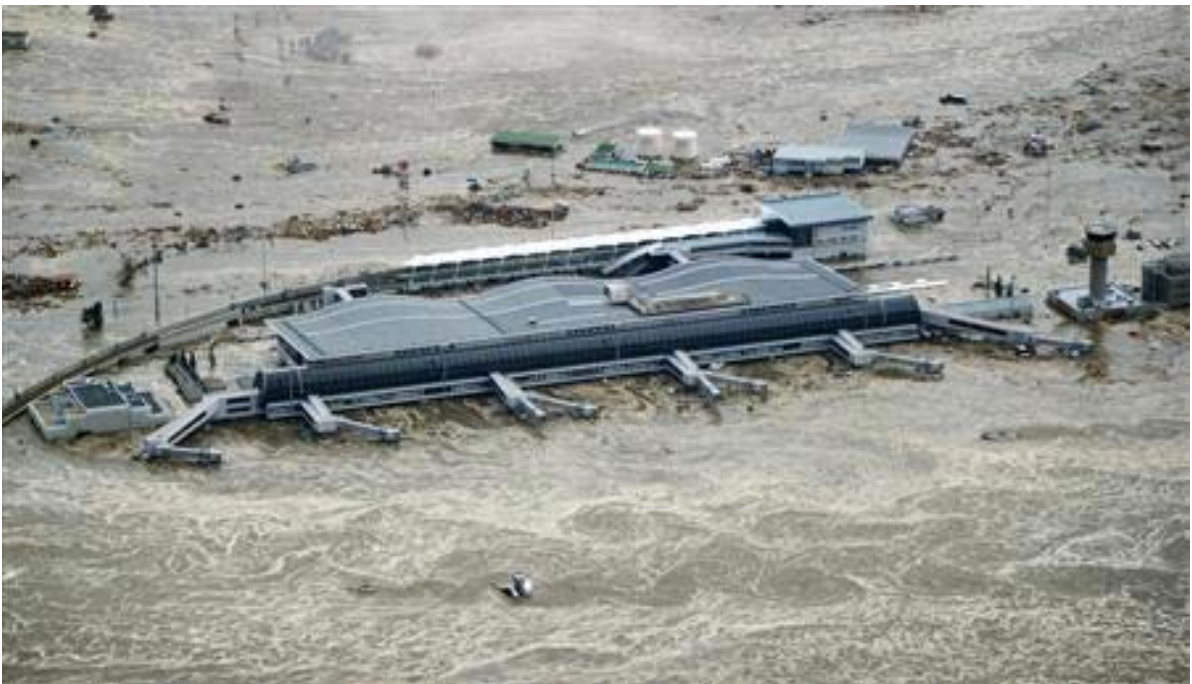
Figure 16 Sendai Airport when inundated by the tsunami. This is taken near the peak tsunami height (4–5 m). Source: Reuters.

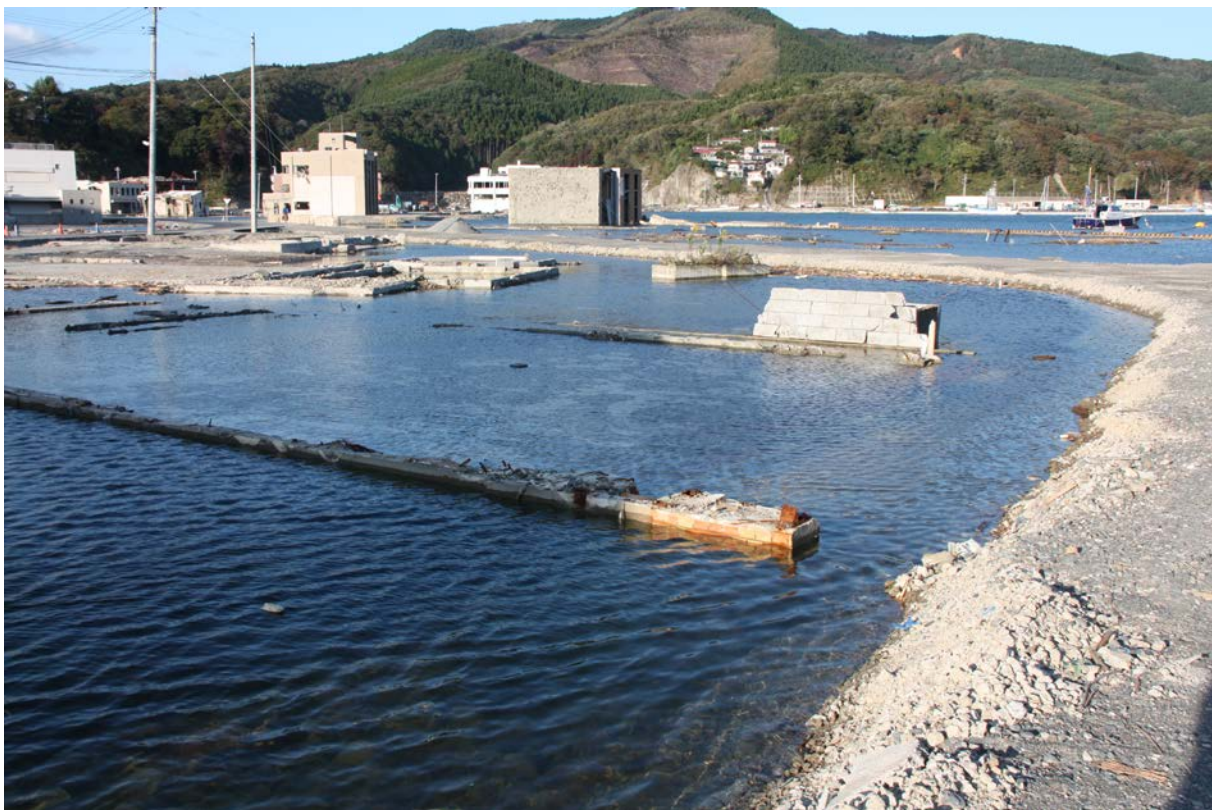
Figure 18 Subsidence reduced ground elevation, resulting flooding land in Onagawa, Japan. Taken six months after the Great East Japan tsunami, new roads have been constructed at a higher elevation. Source: S. Fraser and G.S. Leonard.

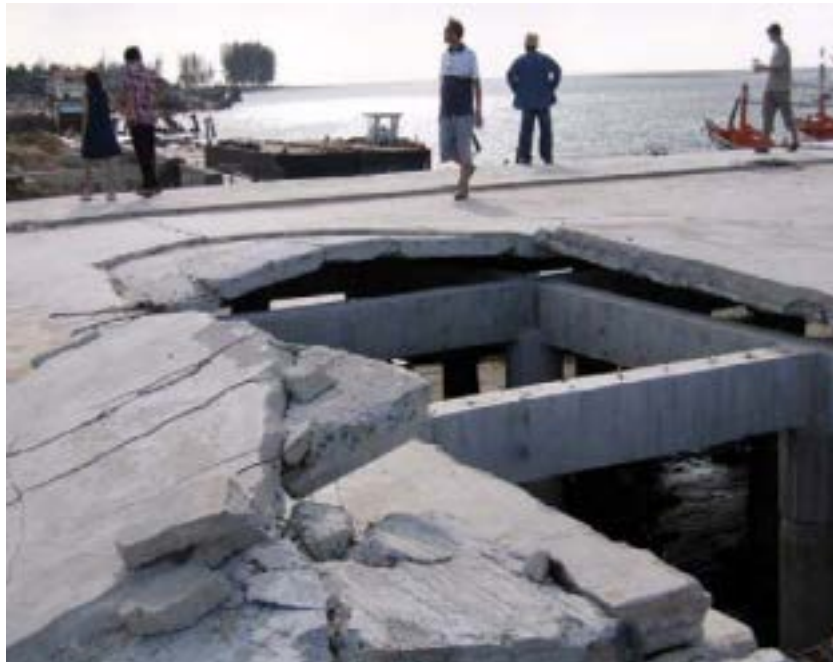
Figure 20 Damage to a wharf deck in Thailand from vertical buoyancy forces. Source: PARI, 2009.

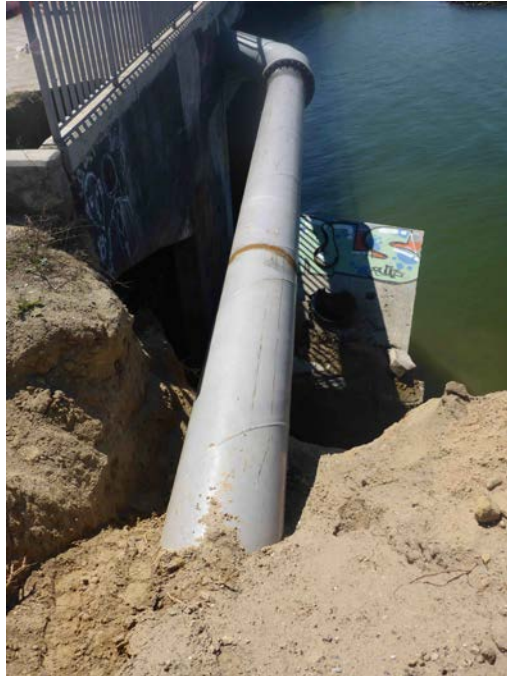
Figure 22 Top: Severed water main where it crosses a bridge in Coquimbo, Chile caused by erosion of the abutment. Bottom: severe scouring that exposed the same water main and caused it to float to the surface. (Horspool et al, 2016).

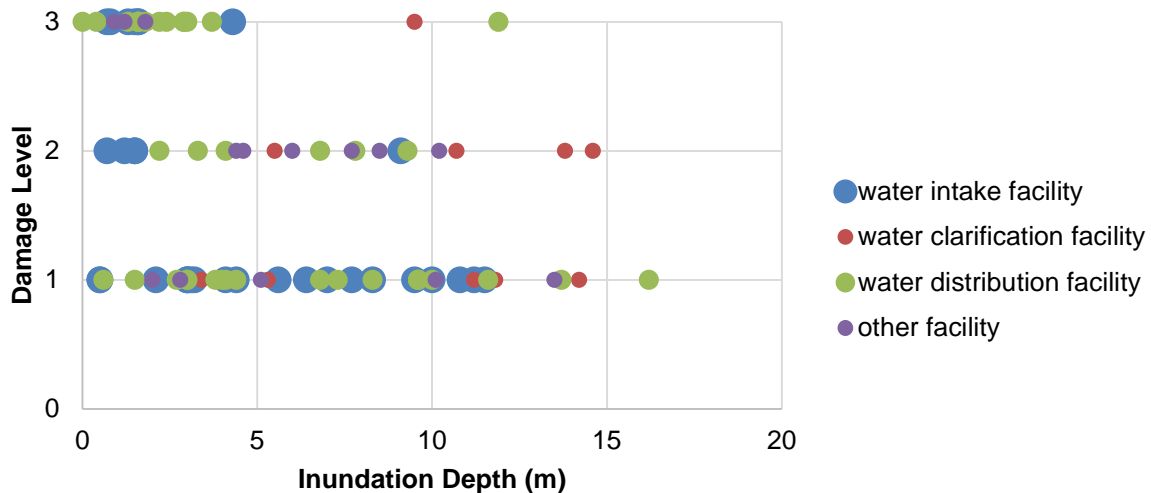
Figure 23 Damage level as a function of inundation flow depth (m) for various potable water facilities where damage level 3 is severe/extensive damage, level 2 is moderate damage, and damage level 1 is minor damage. Note that severe damage states can be reached in relatively shallow inundation depths (< 2m). Data source: MLIT (2012).

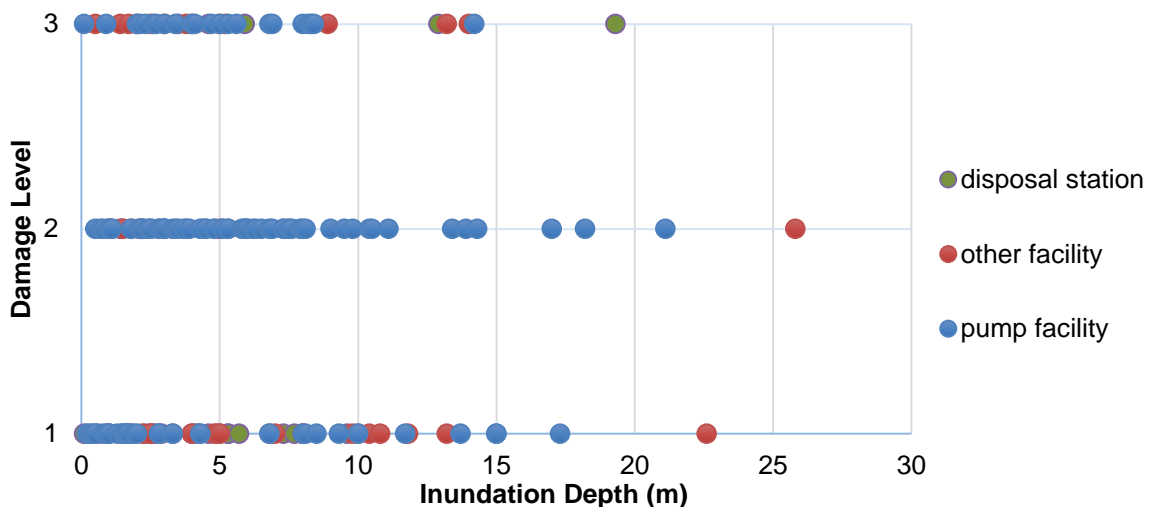
Figure 25 Damage level as a function of inundation flow depth (m) for various wastewater facilities where damage level 3 is the severe/extensive damage, level 2 is moderate damage, and damage level 1 is minor damage. Data source: MLIT.

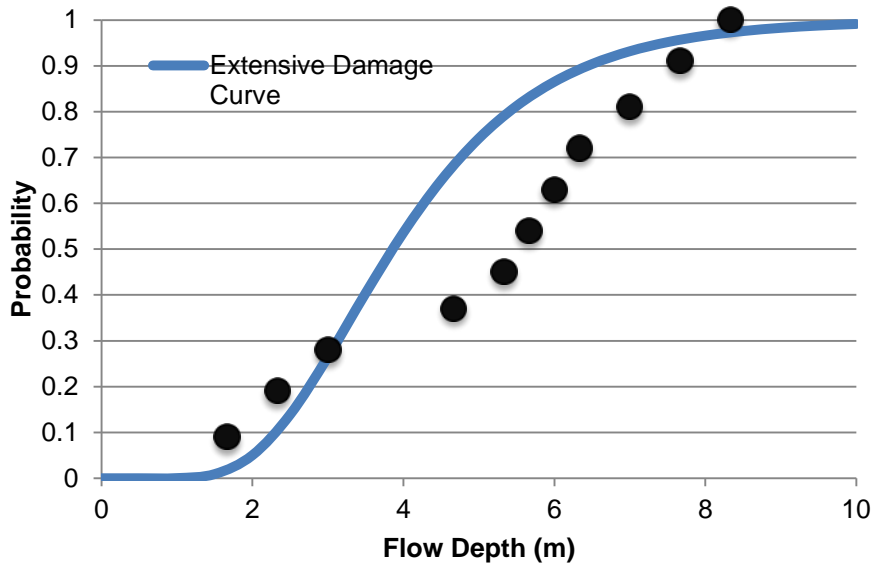
Figure 26 Fragility curve for extensive-complete damage state for generic wastewater facility buildings (mostly reinforced concrete). This fitted curve (blue line) shows the probability of being in the extensive-complete damage state as a function of tsunami flow depth (m). The black circles are observed data from the Great East Japan tsunami. Data source: MLIT.

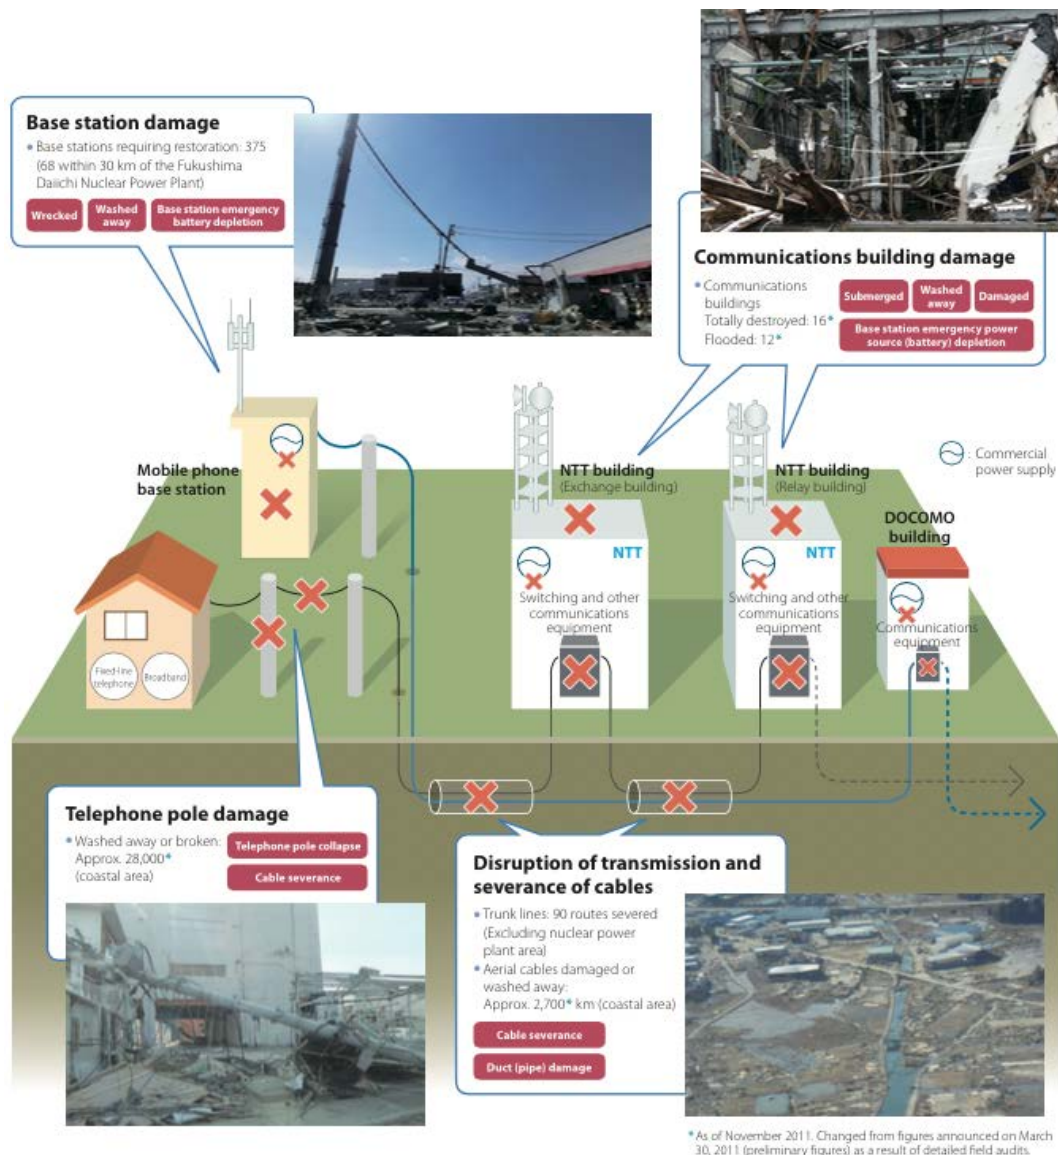
Figure 28 Summary of different types of damage and outages to the wireless and landline communications network during the Great East Japan tsunami. Note that some of the damage was due to the earthquake (e.g., disruption to underground services by liquefaction induced damage). Source: NTT (2011).

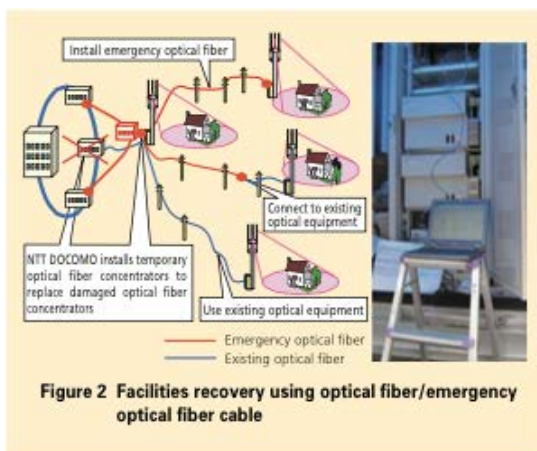
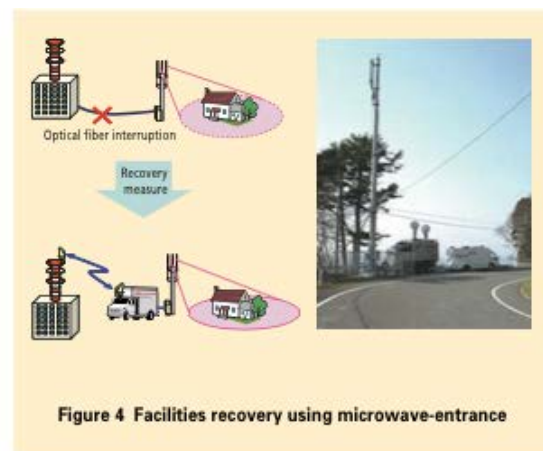
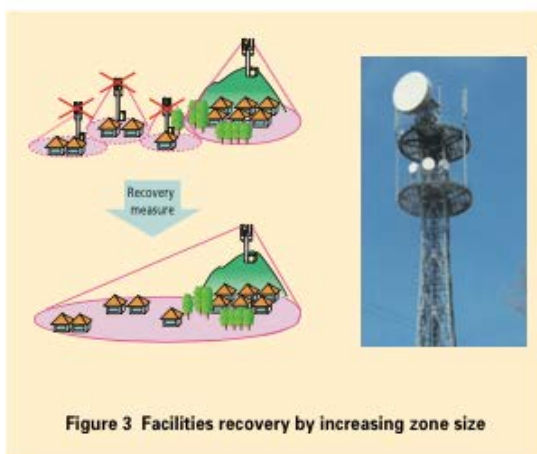
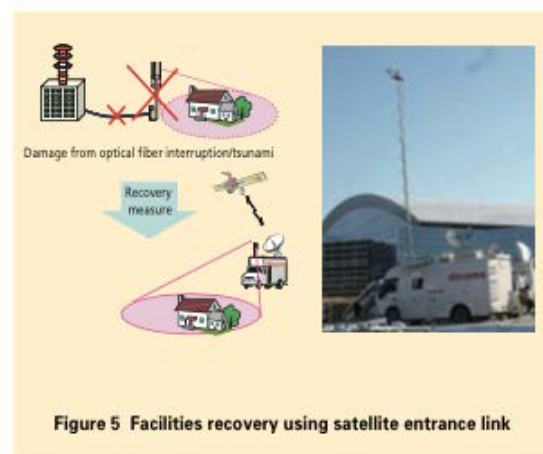
Figure 29 Recovery actions from NTT during the Great East Japan tsunami for various outages of the wireless network. Source: NTT.

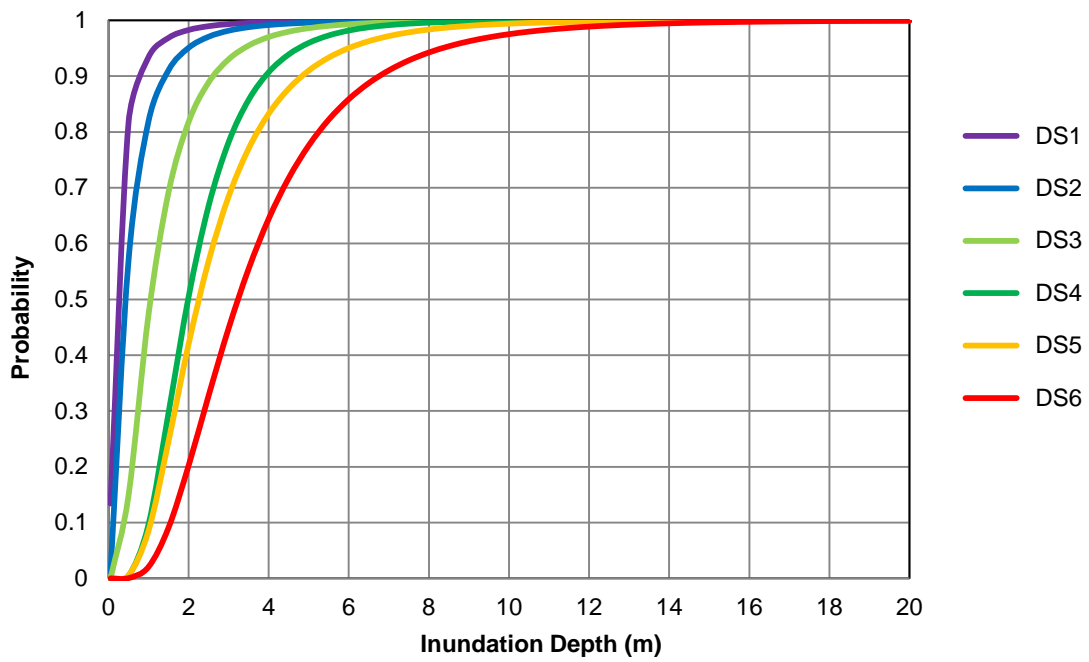
Figure 30 Fragility curve for 1-storey timber frame buildings. Source: Suppasri (2013a).

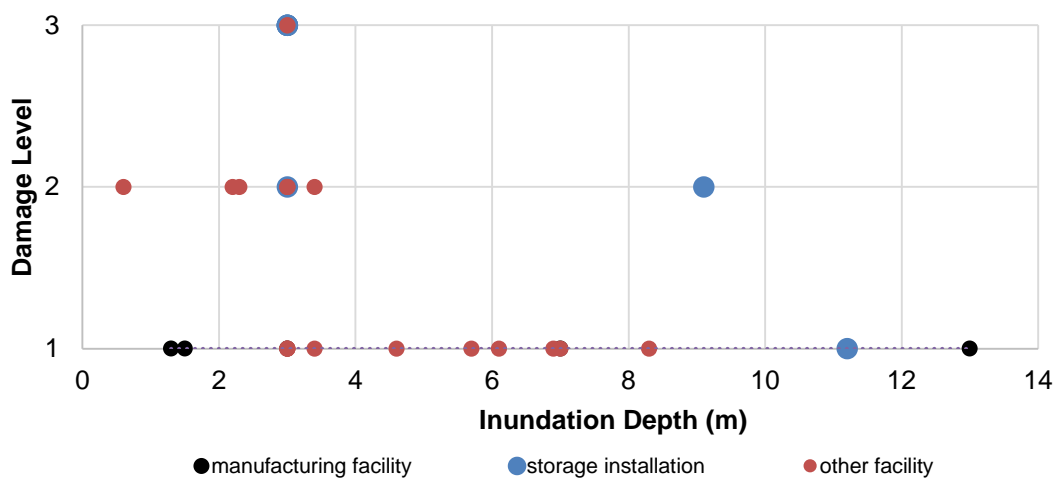
Figure 34 Observed damage data to gas facilities as a function of tsunami inundation depth (Damage Level 1: Minor damage, 2: Moderate damage, 3: destroyed). Source: MLIT (2012).

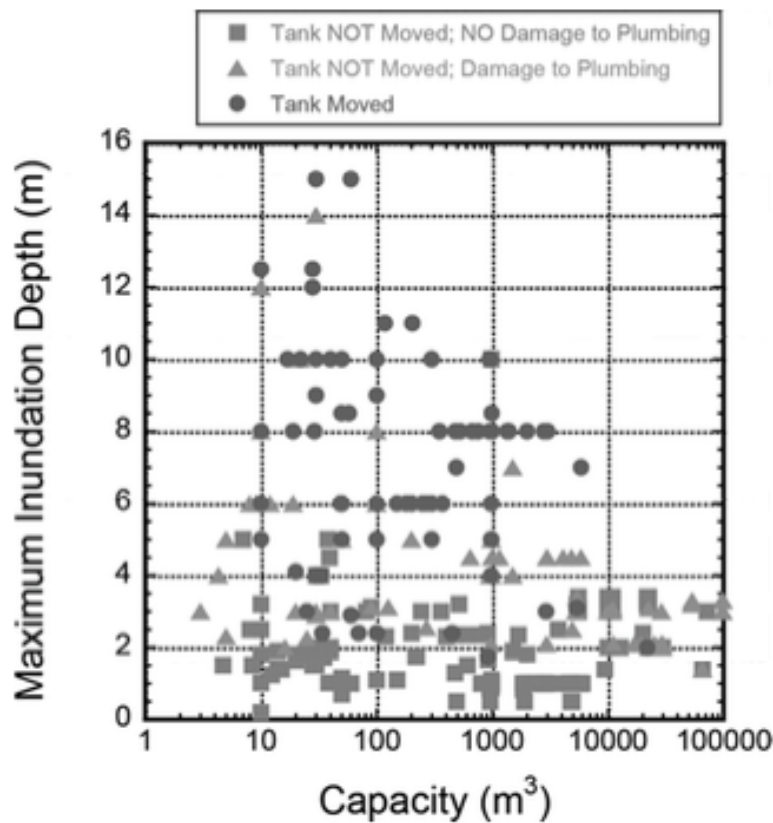
Figure 37 Observations of damage to storage tanks as function of inundation depth (m) and storage capacity. This shows damage to plumbing can occur at ~2m inundation depth, and tank movement at 2–3 m of inundation depth. Source: Hatayama (2014).

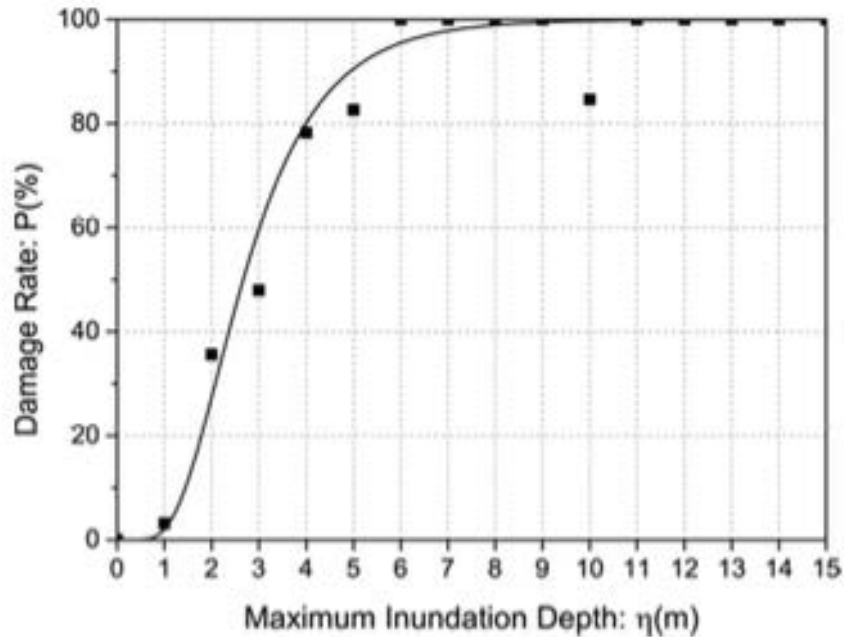
Figure 38 Fragility curve for generic storage tanks. This shows the probability of a tank being damaged as a function of inundation depth (m). The probability of damage increases significantly between 1 m and 5 m inundation depth and reaches 100% at 9 m inundation depth. Source: Hatayama (2014).

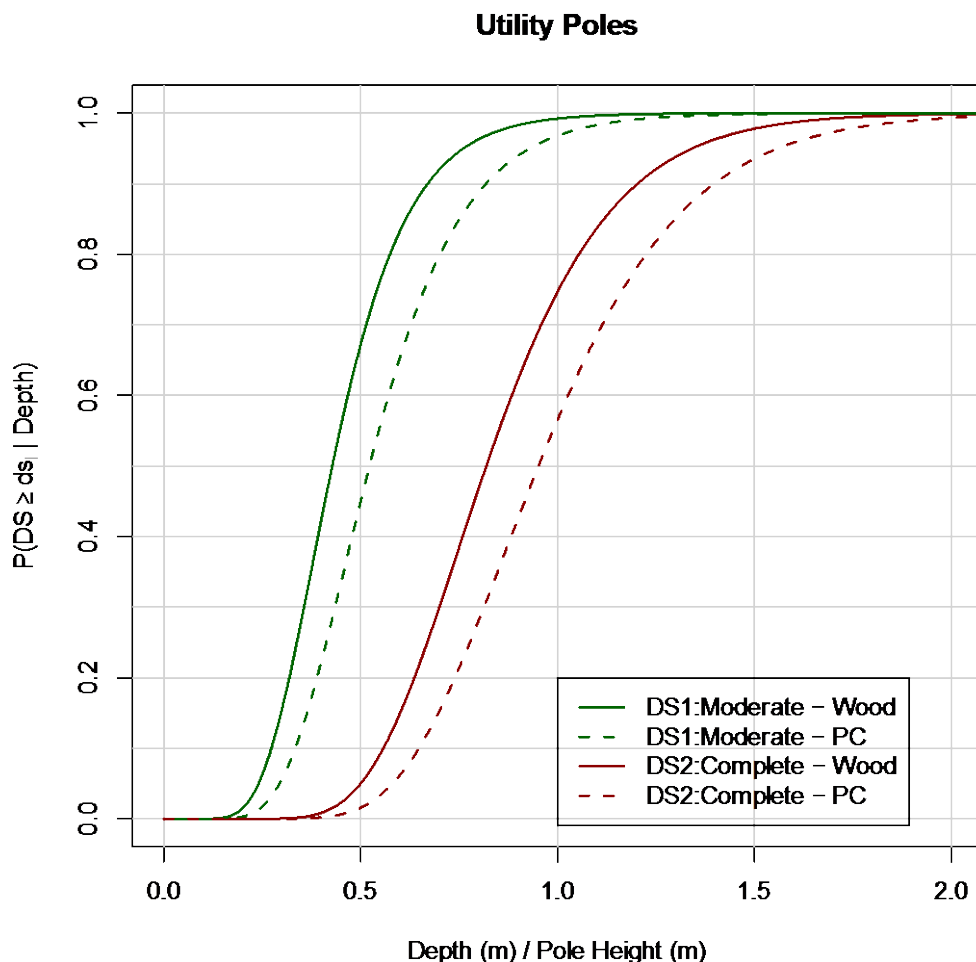
Figure 43 Fragility curve for utility poles constructed from wood or precast concrete (PC) derived from expert judgement and from observations from post-tsunami surveys. The curves show the probability of being in a given damage state or greater as a function of tsunami depth. Damage State 1 (DS1) is defined as damage to the pole such that it is leaning or may need repair, but the pole is still standing. Damage State 2 (DS2) is complete damage where the pole has been washed away.

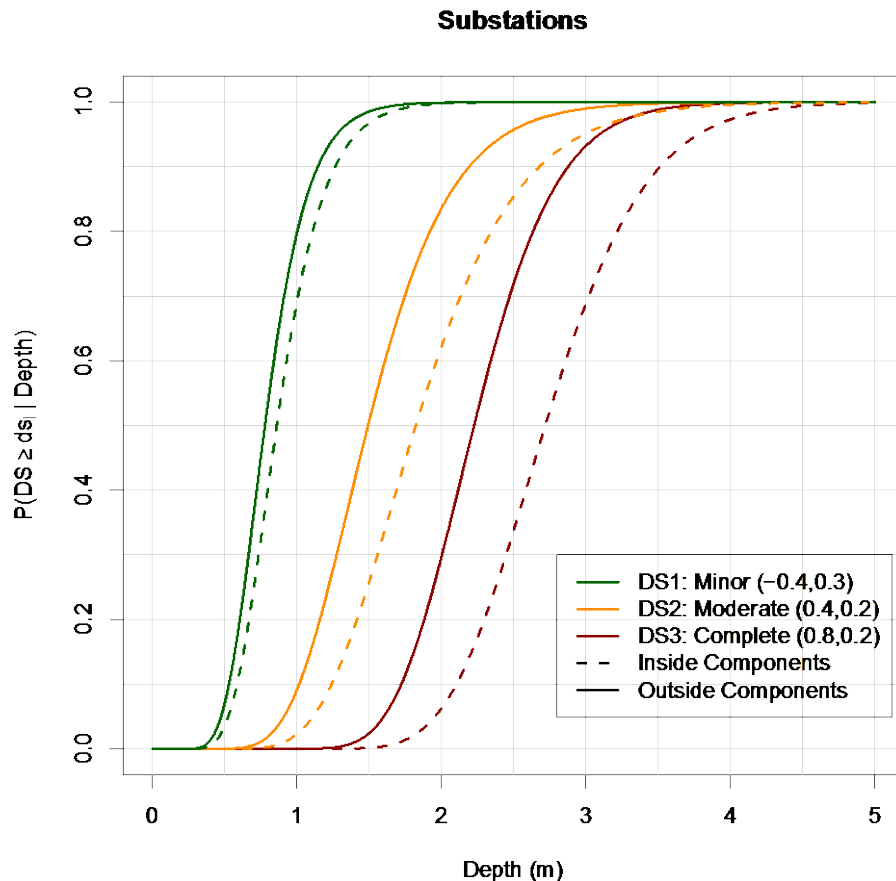
Figure 44 Fragility curves for electrical substations derived from expert judgement and observations from post-tsunami surveys. Each curve shows the probability of being in a given damage state or greater as a function of tsunami inundation depth. Fragility curves are developed for indoor components, usually housed in a small concrete or masonry building and outdoor components in a yard. Damage State 1 (DS1) is minor water damage to substation components with repairs required. Damage State 2 (DS2) is moderate damage where some components have had structural damage and may need replacement. Damage State 3 (DS3) is complete damage where components have been washed away. Loss of service is expected even at damage state 1 due to shorting of the substation.

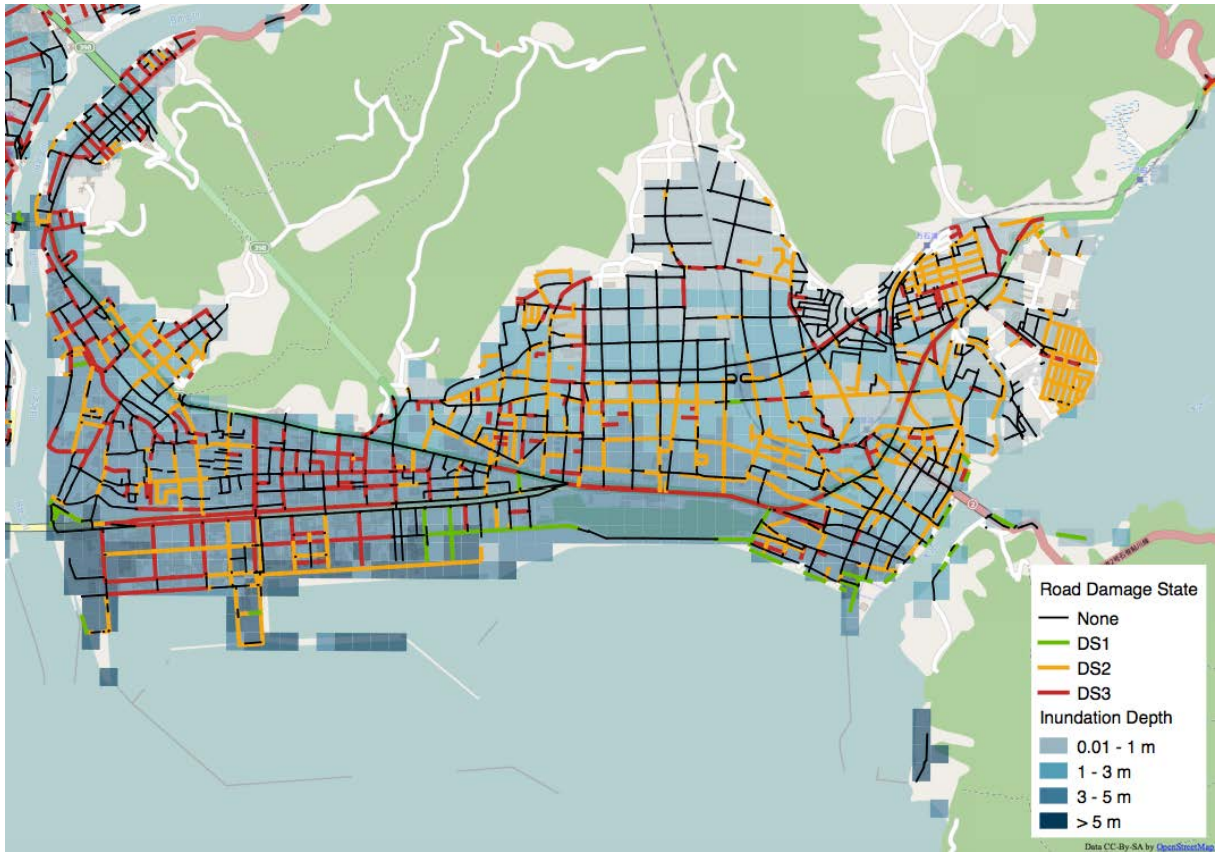
Figure A1 Map showing location of roads and their assigned damage states overlaid on mapped inundation depths for Ishinomaki, Miyagi Prefecture.

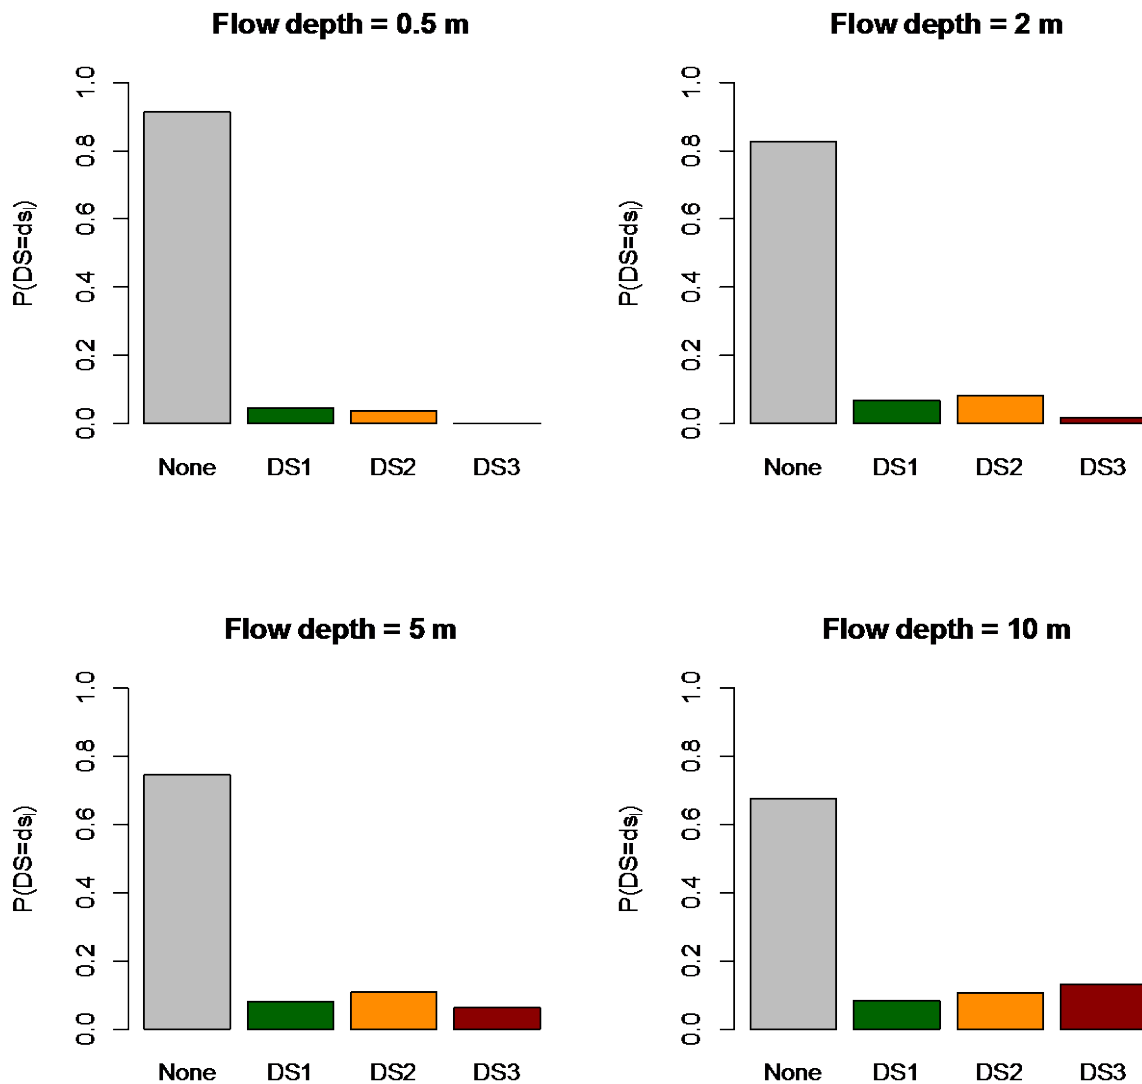
Figure A2 Damage state probability plot for roads. Each plot shows the probability of being in a given damage state for flow depths of 0.5 m, 2 m, 5 m and 10 m. This information was extracted from the fragility curves shown in Figure 5.

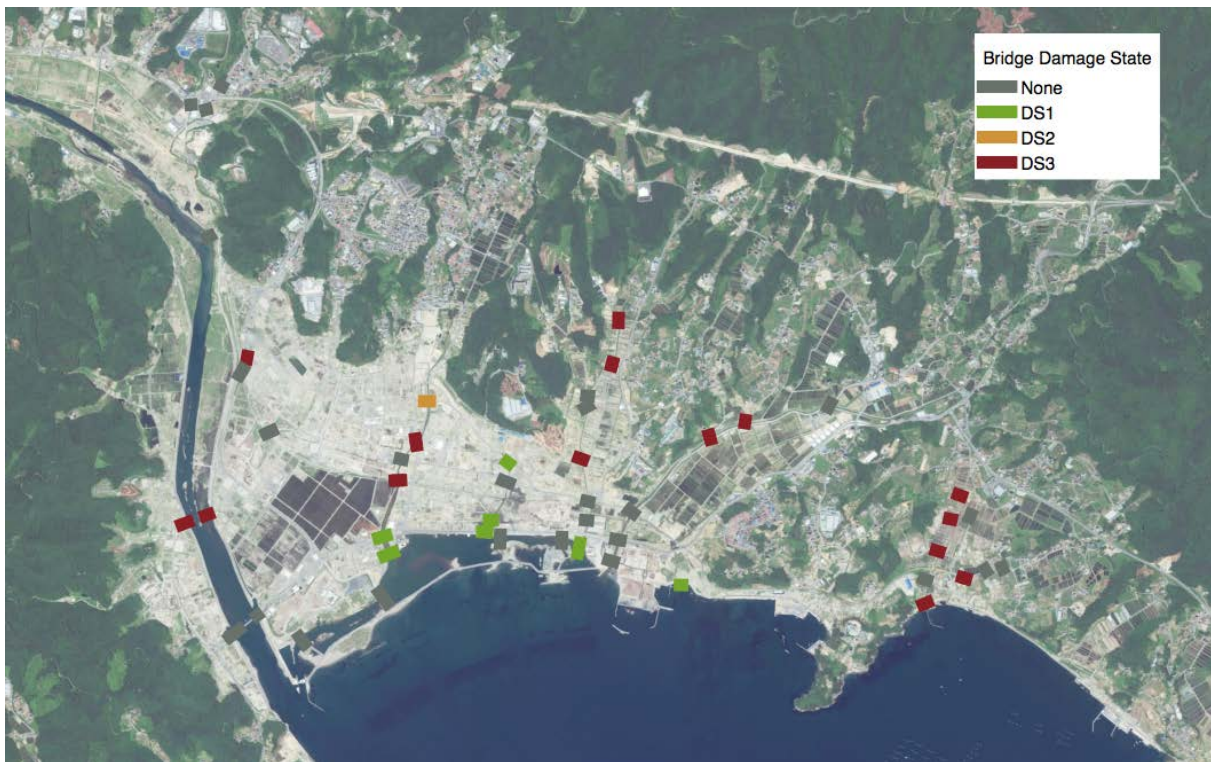
Figure A3 Map showing the location of bridges and their damage states for Rikuzentakata, Iwate Prefecture.
