Research Report

2004-04
ISSN 0110 - 3326

LIQUEFACTION CASE HISTORIES FROM THE WEST COAST OF THE SOUTH ISLAND, NEW ZEALAND

Department of Civil Engineering
University of Canterbury
March 2004

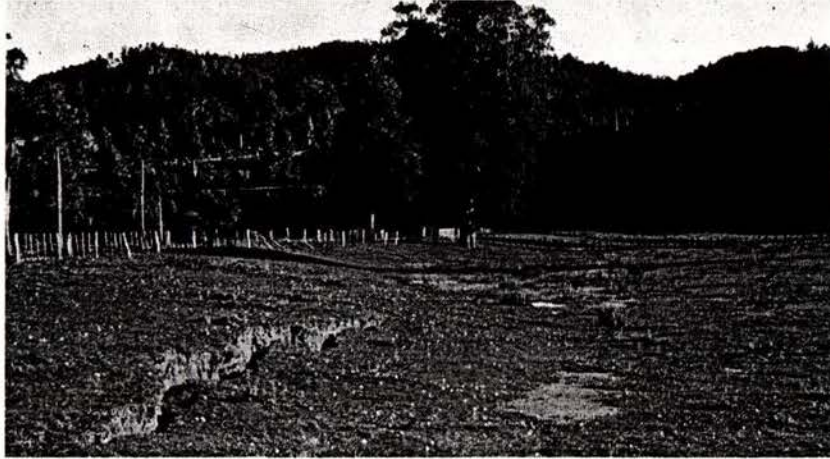
violently and carries suspended sediment with it, which often settles and forms a conical shape around the vent. An example of this is shown below in Figure 2-1.

Figure 2-1. Sand Boils at Three Channel Flat, Inangahua (photo courtesy Dr. A.J. Carr)

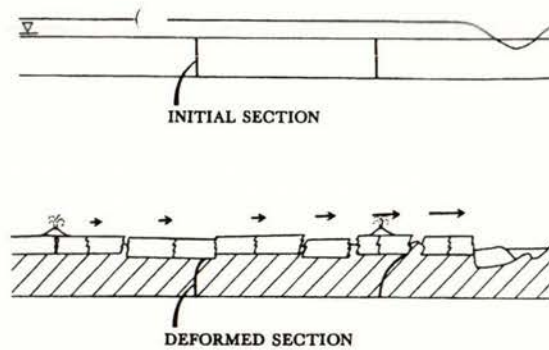
Lateral spreading generally occurs on shallow slopes (usually between 0.3 and 3 degrees) where a complex combination of inertia forces and momentary loss of strength of a subsurface layer can cause the upper layer to break up into blocks which move down slope or towards a free face, such as towards a river channel. Fissures generally separate the blocks created, and the area affected can extend to up to tens or sometimes hundreds of metres. This is shown in Figure 2-2.

Figure 2-2. Lateral Spreading Mechanism (National Research Council, 1985)

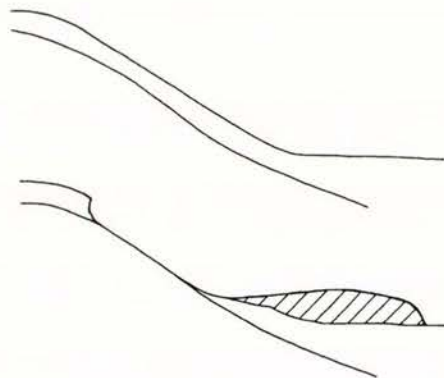
Flow failures generally involve slopes greater than three degrees and occur in loose saturated sands or silts when liquefaction develops beneath the ground surface. The soil loses strength and flows down a slope. The flows may be composed of blocks of intact material, sliding on a layer of liquefied material, or completely liquefied material, as is shown in Figure 2-3 (National Research Council, 1985).

Figure 2-3. Flow Failure Mechanism (National Research Council, 1985)

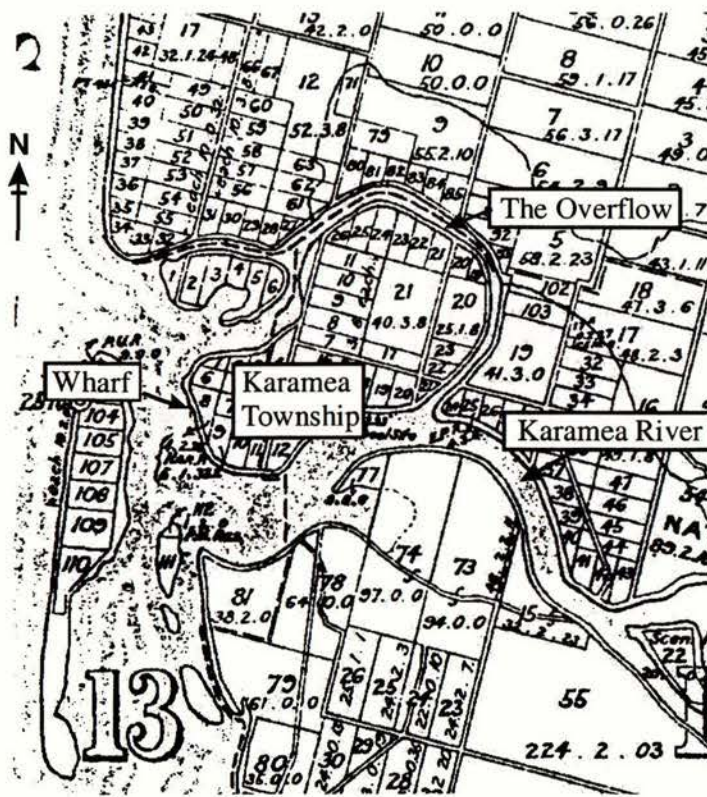
The Karamea River took a different path in 1929 to that taken today, with a now abandoned second channel braiding off to the north and the outlet also to the north and referred to as the Overflow. The map shown in Figure 2-4 was drawn in 1918 and shows that the Karamea Township was situated on what was known as Simpson's Island, which had been formed by the changing course of the braided Karamea River. It is likely to have been built up by the accretion of sand and silt from the river flow, as well as longshore drift along the Karamea Bight. Both the Karamea River and Oparara River mouths have moved considerably over time, as can be seen by comparing the 1918 map with the current map of the area, shown in Figure 2-5. At the river mouth, the river flow rates diminish rapidly as the coast is approached, the rivers become wider and a large amount of sediment is deposited. These deposits are predominantly sand and thus ideally liquefiable materials when saturated. In 1931, the Overflow was blocked off during construction of the flood protection walls. The channel has since filled in, though is visible from above as a small dip in the farm paddocks.

Figure 2-4. Part of a 1918 Map of Karamea (from Archives New Zealand)

As indicated in Chapter 2, the Karamea River took a slightly different path in 1929. The Overflow played an important role in the sediment transport process of the river and as is shown in Figure 2-4 meant that the settlement of Karamea was effectively on an island.

was shown in Figure 2-4, at the time of the earthquake this area was effectively an island between the river and overflow. The effects of liquefaction were likely to have been enhanced due to the susceptible soils of this particular area and the likelihood that the water table was higher than present because of water on both sides of the island.

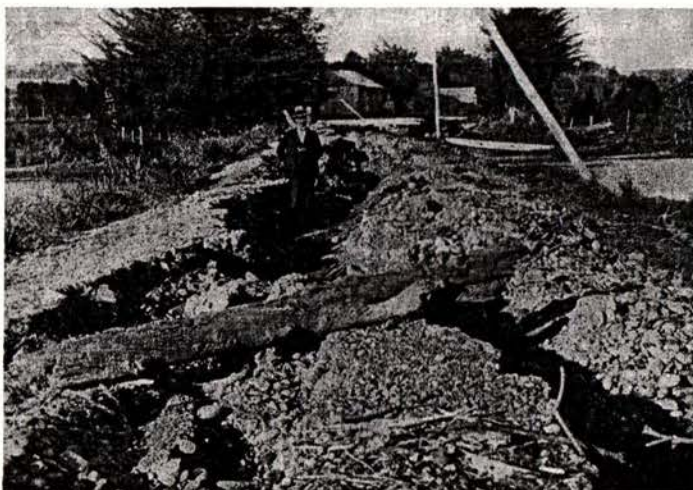
Figure 3-7. Cracks in ground at Quinlans Filling - looking South towards Karamea (photo courtesy of Karamea Museum)

The road at Quinlans Filling is located in Figure 3-3 and the effects illustrated in the photos shown in Figure 3-7 and Figure 3-8.

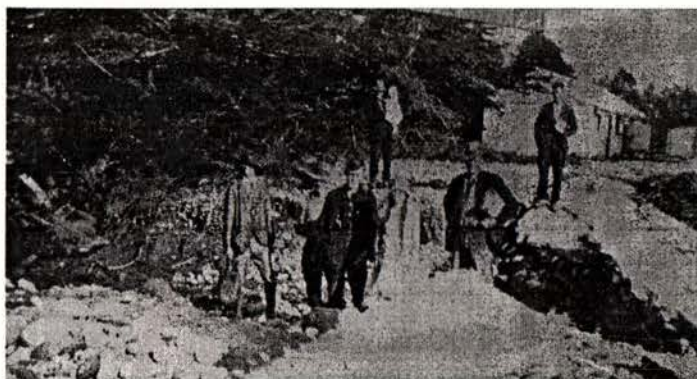
Figure 3-8. Quinlans Filling after the 1929 Earthquake - looking South towards Karamea (photo courtesy Karamea Museum)

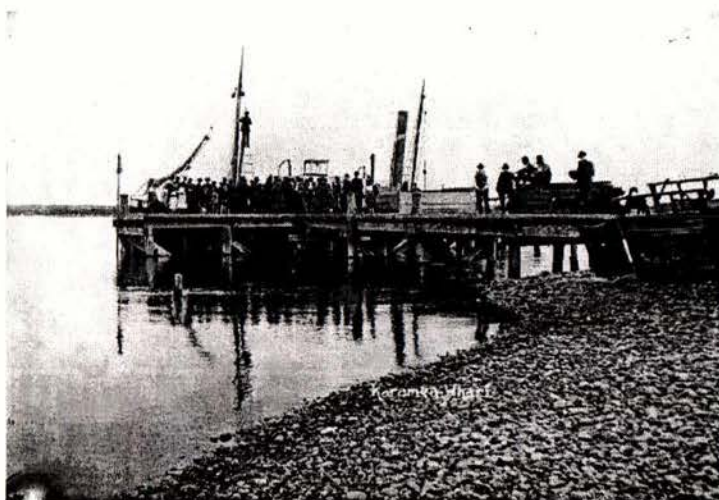
Figure 3-9. Karamea Wharf- circa 1923. (Alexander Turnbull Library)

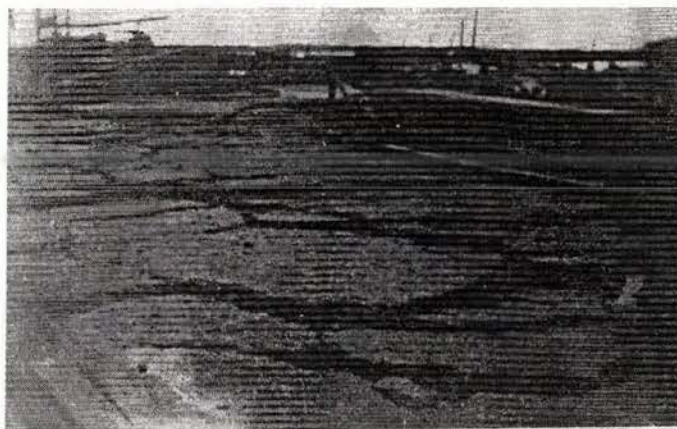
The Nelson Evening Mail (“Postmasters’ Reports”, Friday June 21, 1929, pg 5) initially gave this information by stating that the wharf was leaning into the river and the training wall at the river mouth was considerably damaged in the earthquake. Subsidence was also responsible for the damage to the wharf sheds. This was also recorded in *The Sun* (“Karamea a heap of Ruins”, Friday June 21, 1929, pg 10). This is a clear example of the effects of lateral spreading.

Figure 3-10. Near Karamea wharf after the earthquake (photo courtesy Karamea Museum)

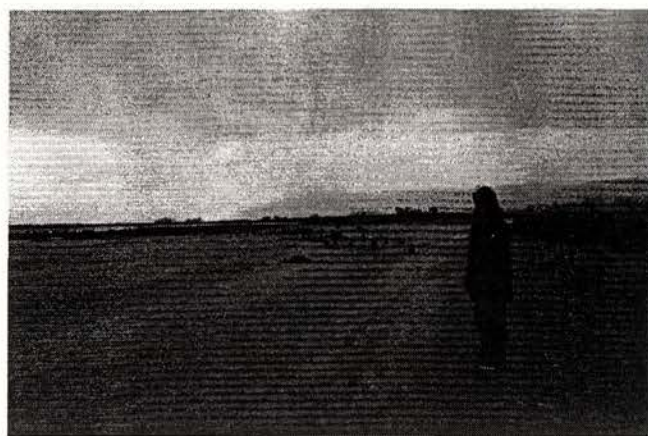
Figure 3-13. Remains of the Karamea Training Wall, North of the Wharf site, January 2003

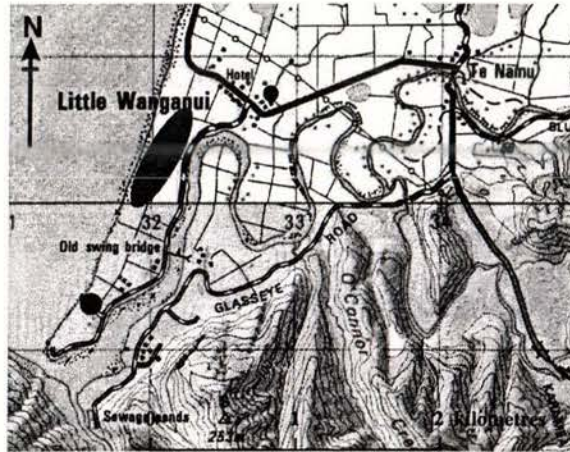
Figure 3-14. Sites of liquefaction at Little Wanganui, 1929 (from Berrill *et al.*, 1988; Base map: Topomap, 2001)

It was reported by Berrill *et al.* (1988) that both Mr. and Mrs. Duncan remembered seeing sand boils in the locations illustrated by the red areas shown in Figure 3-14. Bienvenu (1988) wrote, that Mrs Duncan remembered seeing geysers of water ejected from the cracks formed by the moving ground. No further details regarding this have been found.

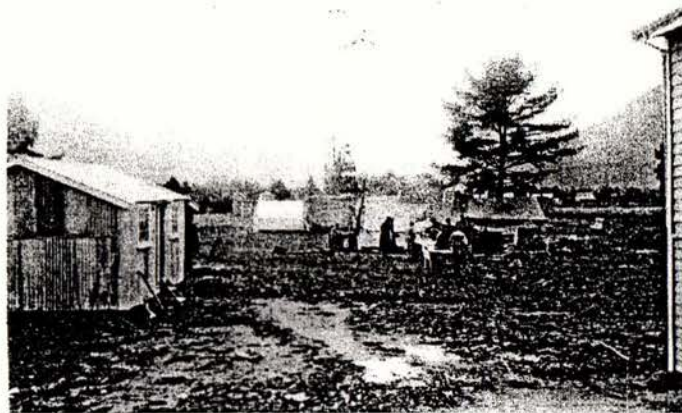
The photo of the camp at Murchison shown in *The Evening Post* (Thursday June 27, 1929), possibly indicates liquefaction with either sand or water in the front of the photo. The camp was located in the school grounds, though following the earthquake there was also a lot of rain. This photo has also been reproduced in the Murchison District Historical and Museum Society Inc. Booklet on the earthquake on page 2.2 and Figure 3-18.

Figure 3-18. School Grounds at Murchison following the earthquake (Murchison District Historical and Museum Society Inc., 1999)

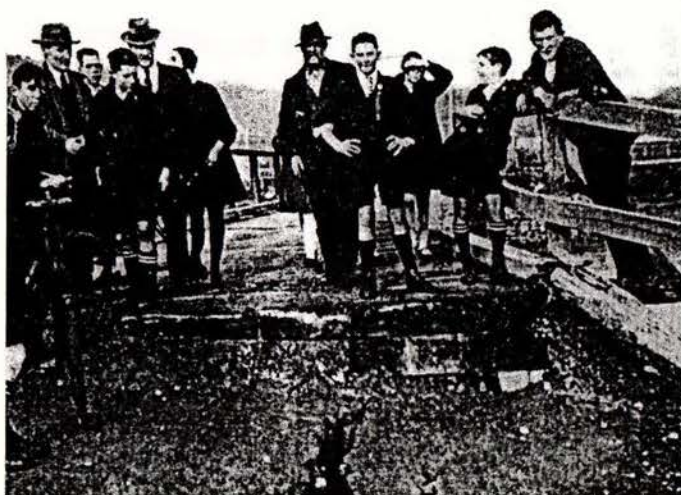
Figure 3-20. Blaketown Footbridge- note the settlement of the approach embankment (*Auckland Weekly News*, 3 July 1929)

The water main feeding Blaketown was in the river bank by Richmond Quay and at first it appeared considerably damaged. In the *Grey River Argus* (June 18, 1929, Article: A Terrific Earthquake from West Coast to Nelson) it was noted that, “*There was not a break in the cast-iron pipe, but a joint pulled out in Richmond Quay due to the roadway settling towards the river*”. Men working to repair breaks in the water mains on Mawhera Quay were shown in a picture in the *Auckland Weekly News* (July 17th, 1929). Mr. George Webster (pers. comm., April 2003) confirmed this, and stated that the footbridge to Blaketown was at the end of the Quay. The approach embankment to the footbridge appears to have settled from the photo in the *Auckland Weekly News* shown in Figure 3-20.

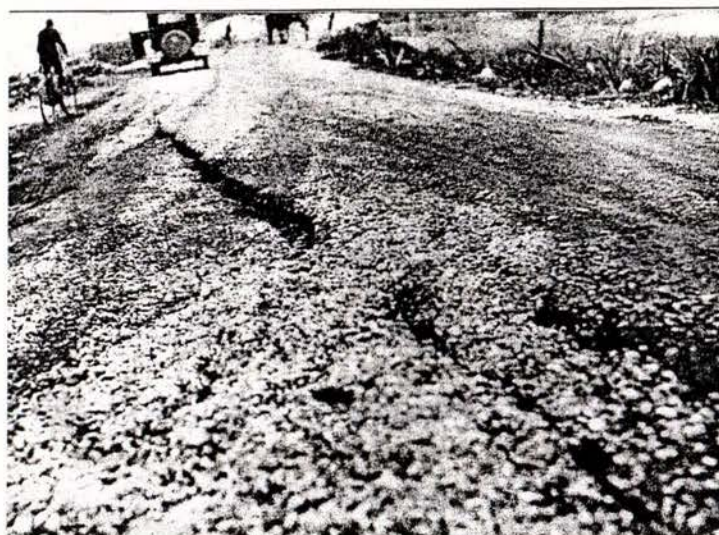
Figure 3-21. Cracks in Preston Road at Blaketown (*New Zealand Free Lance*, 26 June 1929)

It was stated in *The Dominion* (24 June 1929) and shown by photographs that there were cracks in the ground in Preston Road. Dowrick (1993) inferred that this was on made ground in a swampy area. The *New Zealand Free Lance* printed the following picture (Figure 3-21) to illustrate the fissures and the creamy silt and salt water that they stated came through these cracks.

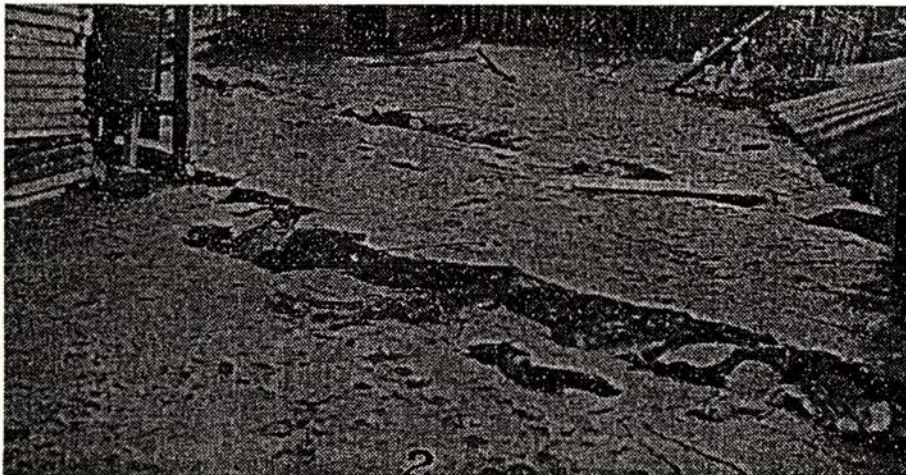
The nature of this event was also noted in *The Nelson Evening Mail* (“Greymouth”, June 20, 1929, pg 5) where they reported that the deposit was spread, “over an area of about twenty or thirty square yards”. *The Dominion* (24 June 1929) printed a picture of the cracks in Mr. Negri’s back yard at Blaketown. Underneath the picture it was written that the “water squirted up from these cracks to a height of 6 to 8 feet and covered the yard”. This picture has been reproduced and is shown in Figure 3-23. Mr. George Webster (pers. comm., April 2003) confirmed that Mr. Negri lived on the western corner of Blake and Collins Streets.

Figure 3-23. Backyard of property owned by Mr A. Negri, Blaketown, 1929 (*The Dominion*, 24 June 1929)

An 1879 Plan of the area, drawn up for the design of the wharf and training walls, shows that this property would have been built on reclaimed land, or land which has been built up by longshore drift along the coast.

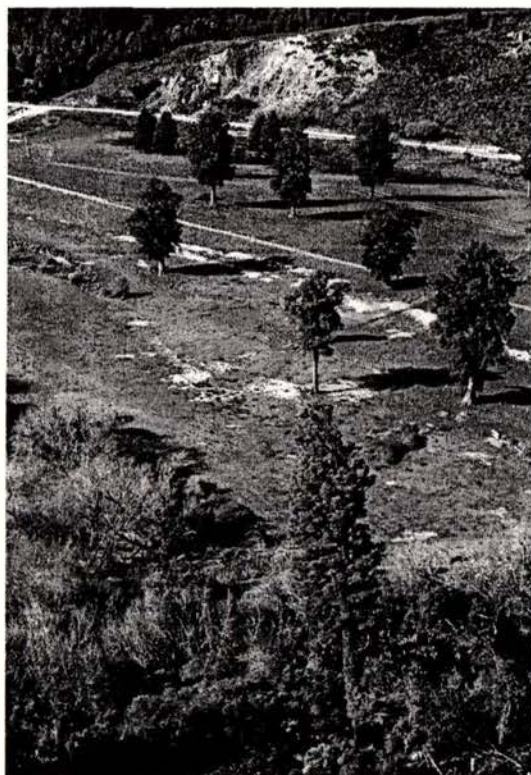
Three Channel Flat, located about 10 km southwest of the epicentre and very close to the centre of the aftershock pattern, showed the most intensive sand ejection in comparison to other sites according to Berrill (1987, 1988). A photo indicating the extent of the sand boils on this flat can be seen in Figure 4-6.

Figure 4-6. Sand boils on Three Channel Flat following the 1968 Inangahua earthquake (photo courtesy Dr. A.J. Carr)

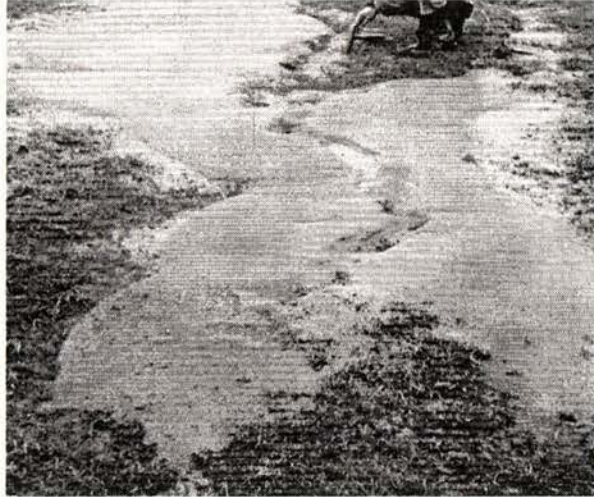
these on Hotham Street, as shown in Figure 4-7. He remembered seeing the water pulse out of the crack as the crack opened and closed, and continued to do so four hours later, though at this time the flow was smaller and was closer to the centre of the sand boil. Dr. Collen also noted that the fine grained particles flowed out to the edge of the sand boil while the coarser material remained closer to the vent (pers comm., April 2003).

Figure 4-8. Sand Boils adjacent Hotham Street, Murchison (photo courtesy Dr. John Collen)

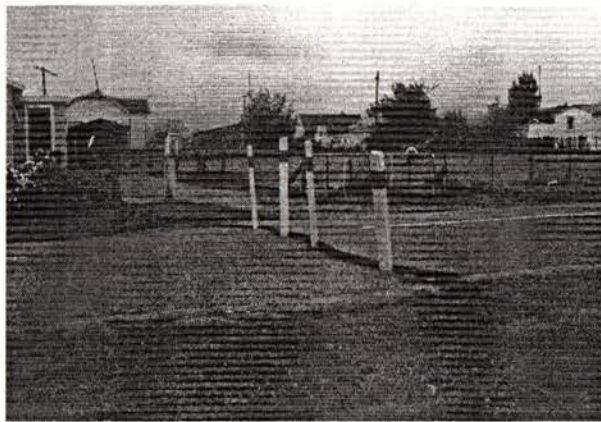
Dr. Collen wrote, *“The road near the sand boils was fractured with a gap of 10-15cm, upthrown by about the same amount to the west”* (pers. com. May 2003) and this is illustrated by the following photo in Figure 4-9 which was taken nearby.

Figure 4-9. Crack across Hotham Street, Murchison (photo courtesy Dr. John Collen)

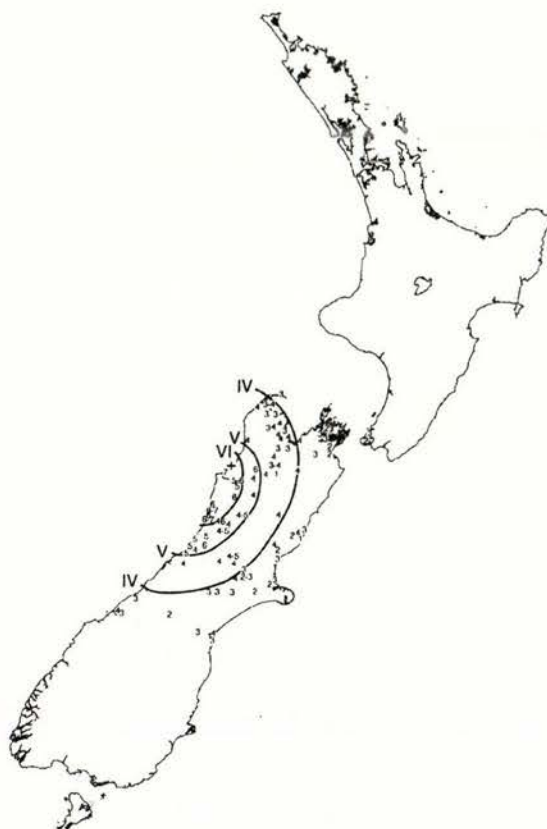
Figure 5-1. Isoseismal Map for the 1962 Westport Earthquake (Downes 1995)

In May 1962, a series of shallow earthquakes were felt in the Westport area. The effects were felt significantly in the immediate area but were also fairly widely felt as can be seen in the following isoseismal map in Figure 5-1.

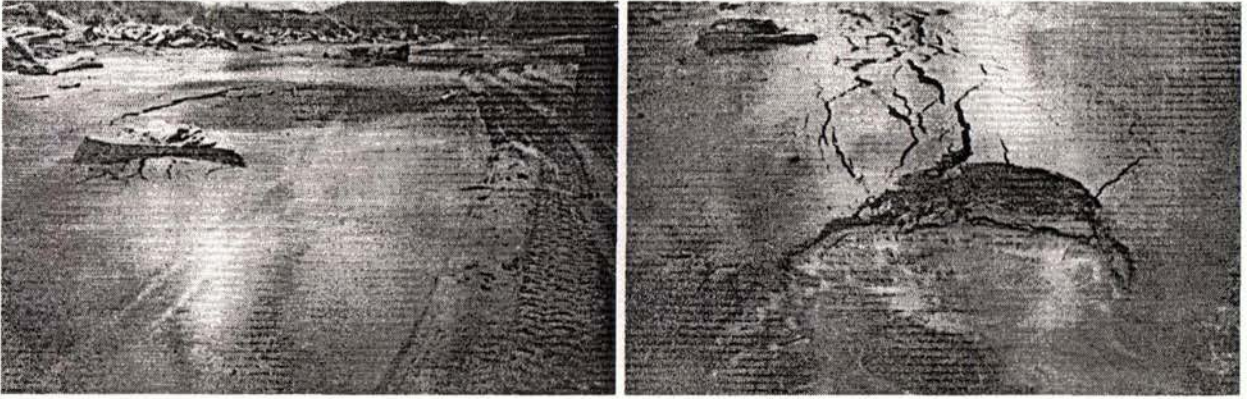
It was noted by Benn (1992) that at the southern end of Nine Mile Beach, Charleston, sand boils and cracks were formed. Logs were left “*perched on pedestals of sand*” as subsidence occurred around the large driftwood logs. The photographic evidence shown in Figure 5-4 supports these statements.

Figure 5-4. Photos of Sand Boils at Nine Mile Beach, Charleston (Benn, 1992)

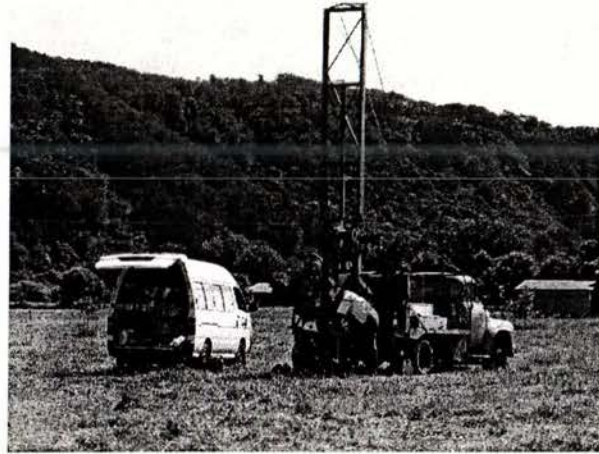
Figure 6-3. University of Canterbury Drilling Rig at Arapito (February 2003)

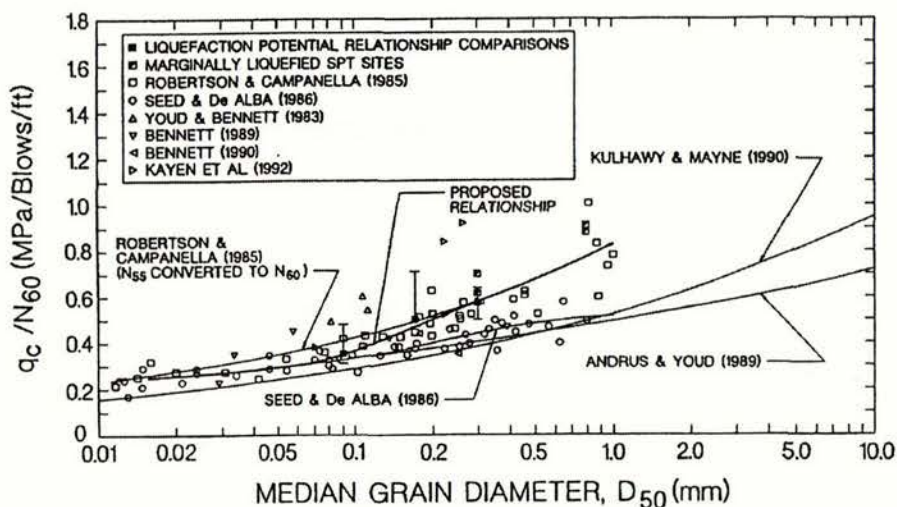
Figure 7-2. Conversion of SPT- N values to CPT- q_c values (from Stark and Olson, 1995)

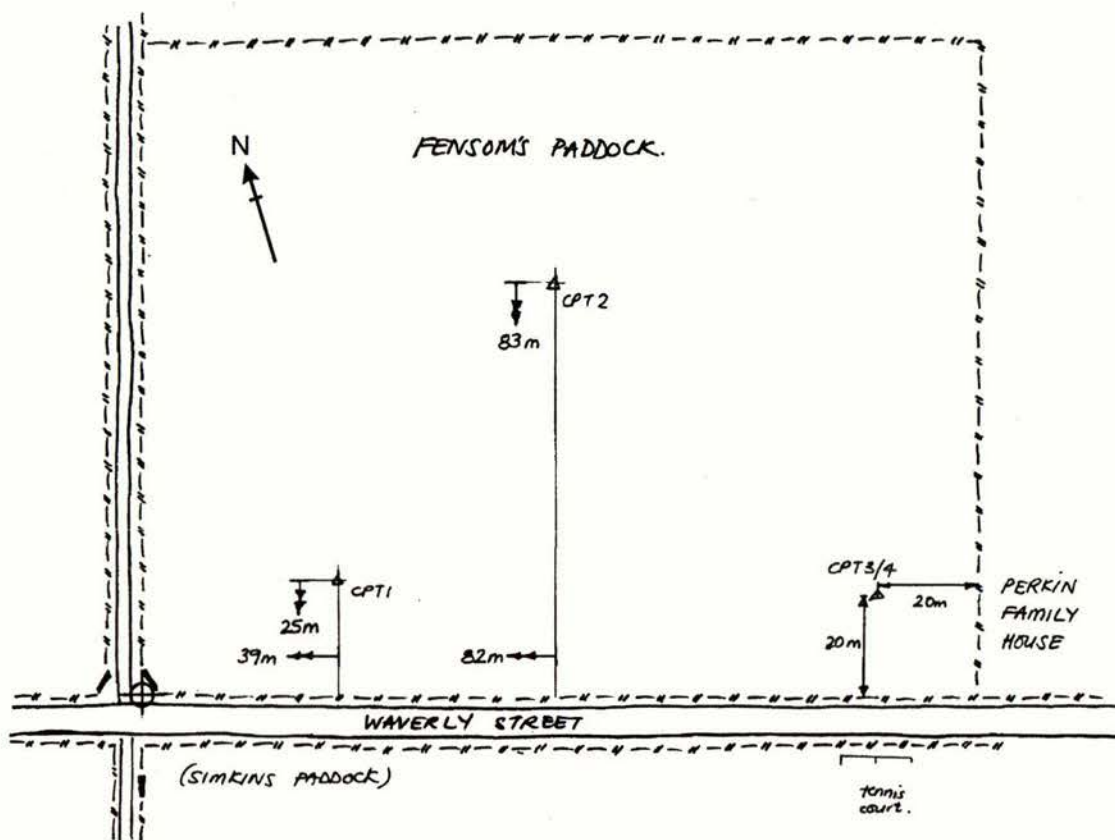
Figure 8-9. Site diagram indicating locations of CPT tests in Fensom's Paddock, Karamea

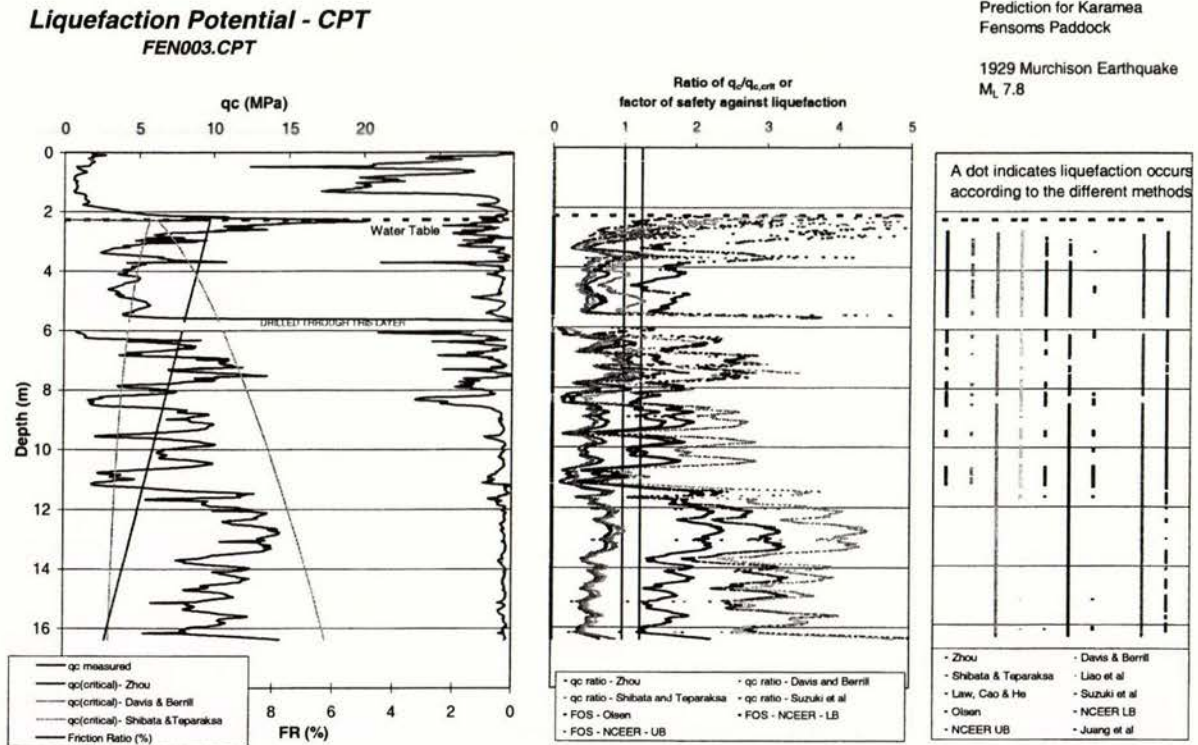
Figure 8-10. Liquefaction analysis plot Fensom's Paddock for the 1929 Murchison Earthquake

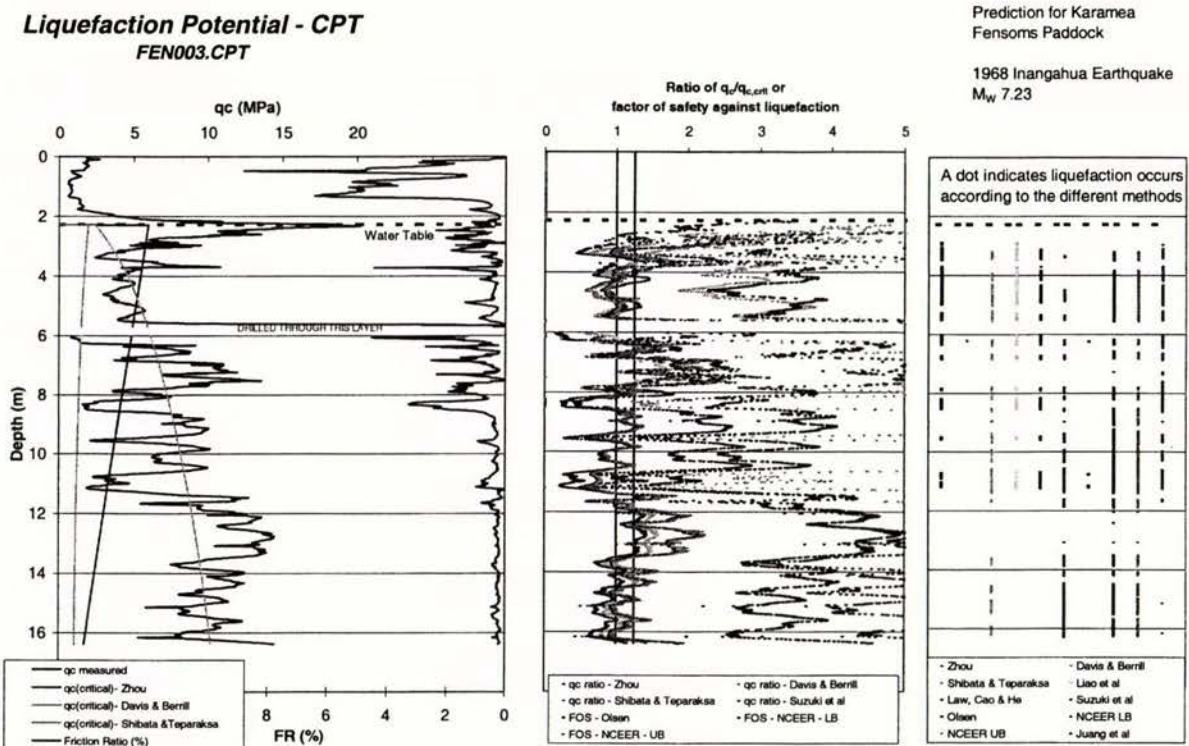
Figure 8-11. Liquefaction analysis plot for Fensom's Paddock for the 1968 Inangahua Earthquake

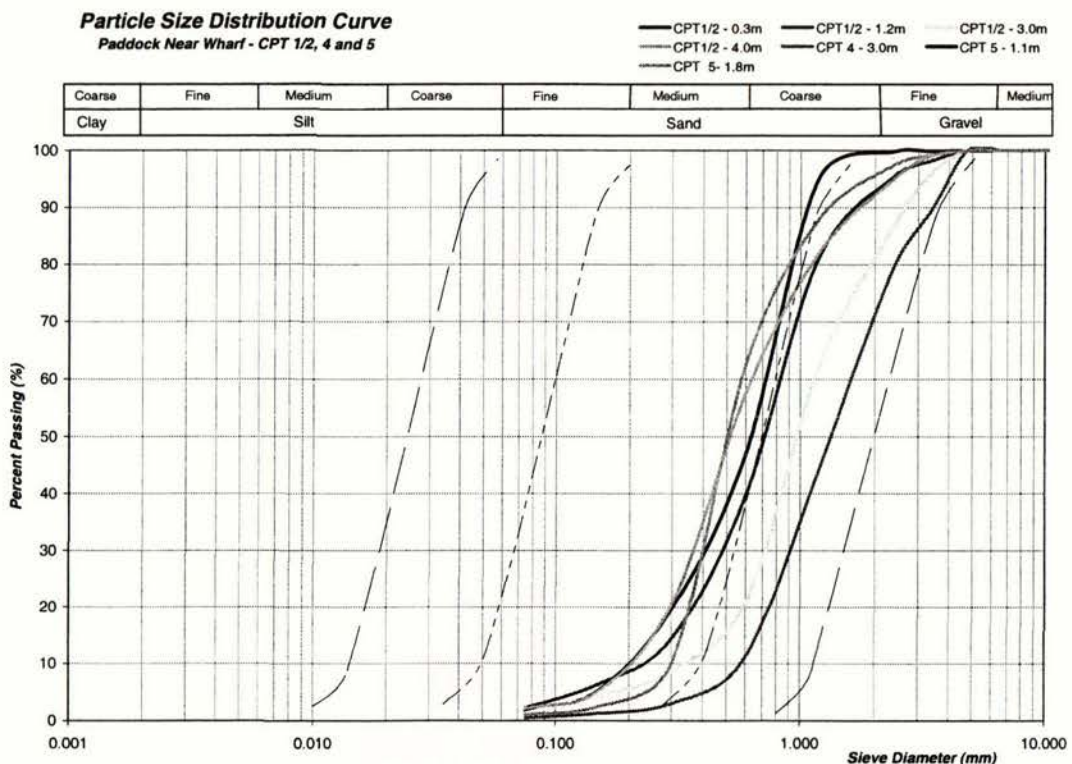
Figure 8-13. Particle size distribution of samples from the paddock near the wharf site

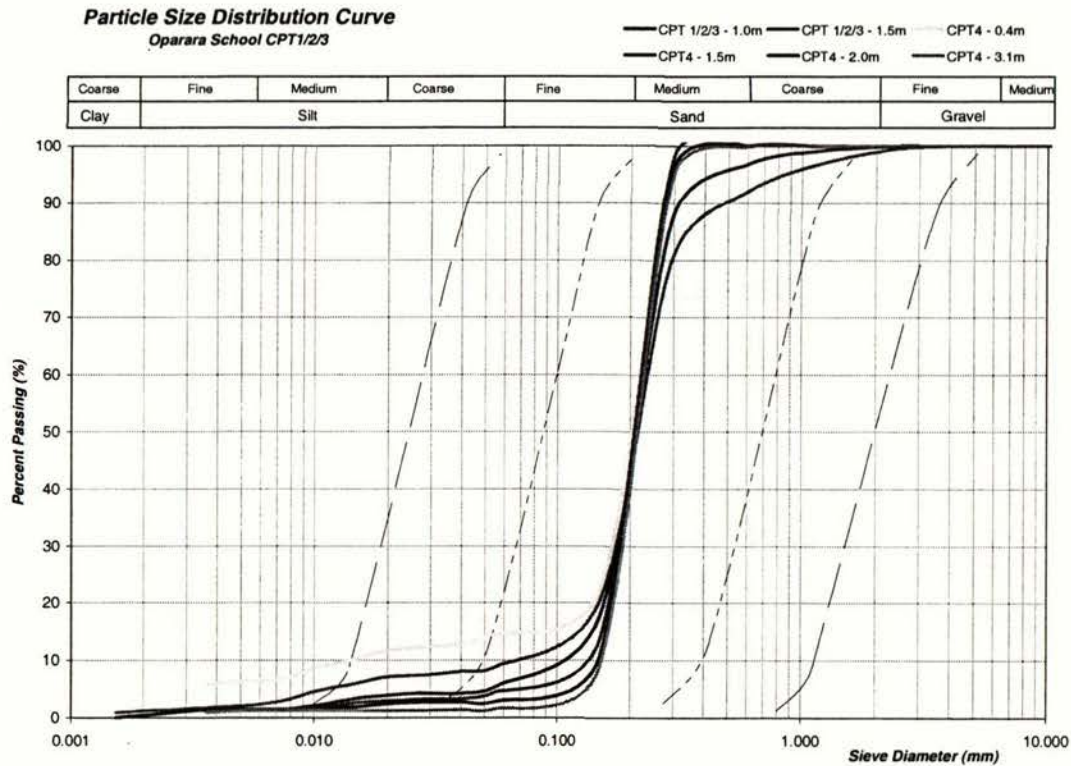
Figure 8-14. Particle size distribution for Oparara School site

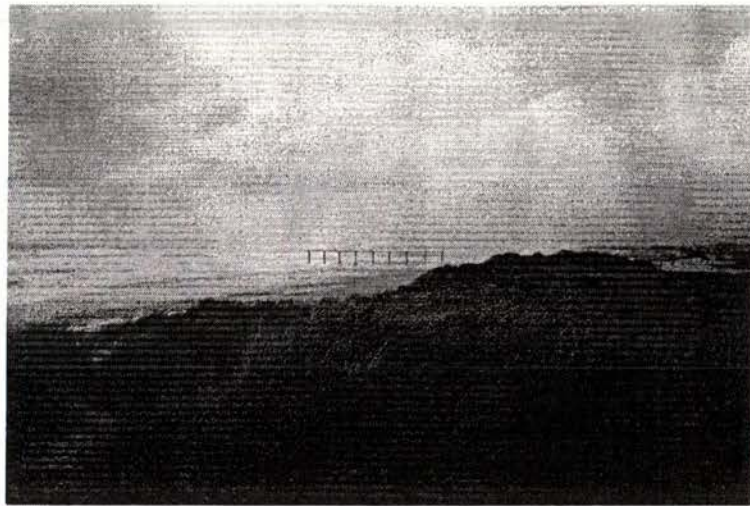
Figure 8-15. Coastal erosion indicated by the Dairy Factory outlet pipe that originally protruded from the sand dunes

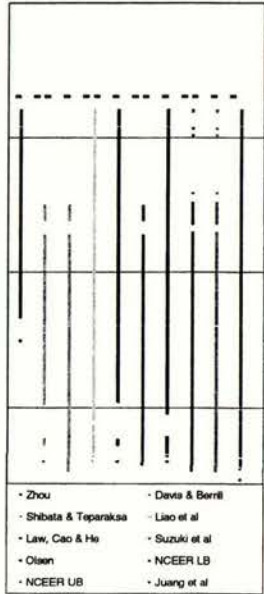
Prediction for Inangahua
Turners Farm, Walkers Flat
1968 Inangahua Earthquake
 M_w 7.23

Liquefaction Potential - CPT
WT5009.CPT
