## **Final-Reporting-2**

Behaviour and Design of Composite Metal Deck Diaphragms Subjected to In-plane Shear Forces

Hooman Rezaeian

The University of Auckland

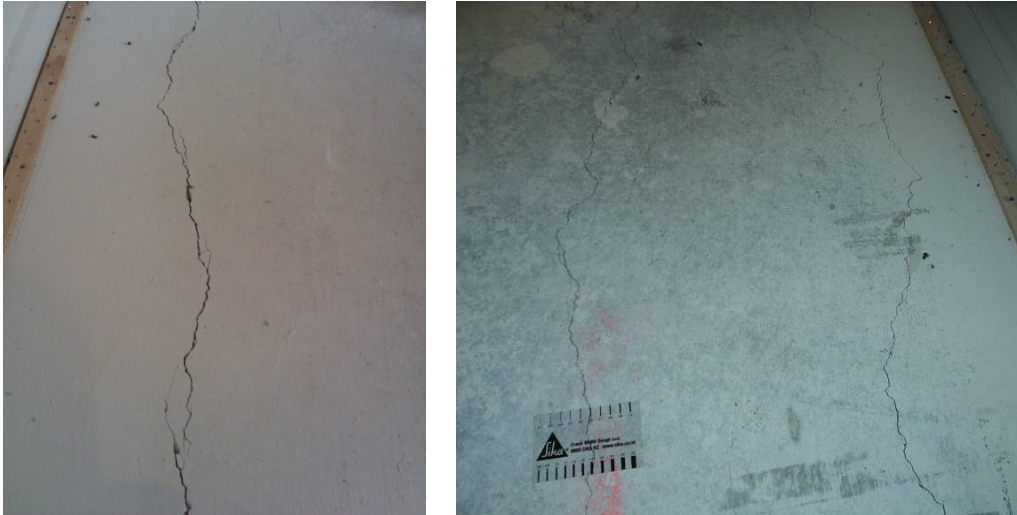
Figure 2. Pacific tower floor cracks after Christchurch earthquake 2011

In New Zealand, inelastic response of diaphragms designed to be elastic was observed in many reinforced concrete buildings in the Canterbury earthquake series of 2010 and 2011. In some instances, this was sufficiently severe to result in the demolition of these buildings, even though the seismic resisting systems performed well. The same behaviour was observed following the Kaikoura earthquake of November 2016 in Wellington, where a number of reinforced concrete buildings constructed after 1970, needed to be either demolished or have major repairs. In the case of the steel structures, the composite slab diaphragms exhibited cracks and damage, mostly across the edge zone where the diaphragm in plane forces transfer to the seismic resisting system (see Fig. 2). There was some uncertainty about their residual seismic capacities.

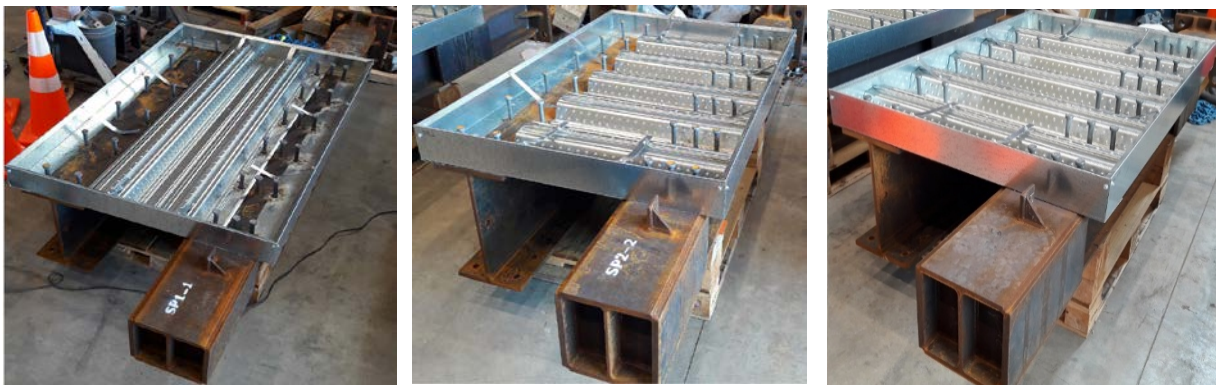
a) Sp1

b) Sp 2 (New Zealand detail)

c) Sp 3 (European detail)

Figure 7. Photograph of specimens

Fig. 7 shows details of the three specimens. As can be seen from Fig. 8, the tested slabs were 1700 mm long in the loading direction, 1160mm wide, 125 mm thick, with 65mm concrete topping on the deck. A total of 18 and 12 headed shear studs were welded to the loading beam and reaction beam respectively and embedded into the concrete slab.

For the first specimen, the rib orientation was parallel to the supporting beams. For the second specimen, the rib orientation was perpendicular to the supporting beams. However, the deck did not continue over the top flange to give a solid concrete rib along the beam. This is the more common edge detail in New Zealand, as it gives a robust slab edge anchorage which is desirable for severe earthquake and severe fire. For the third specimen, the rib orientation was perpendicular to the supporting beams and the deck continued over the top flange.

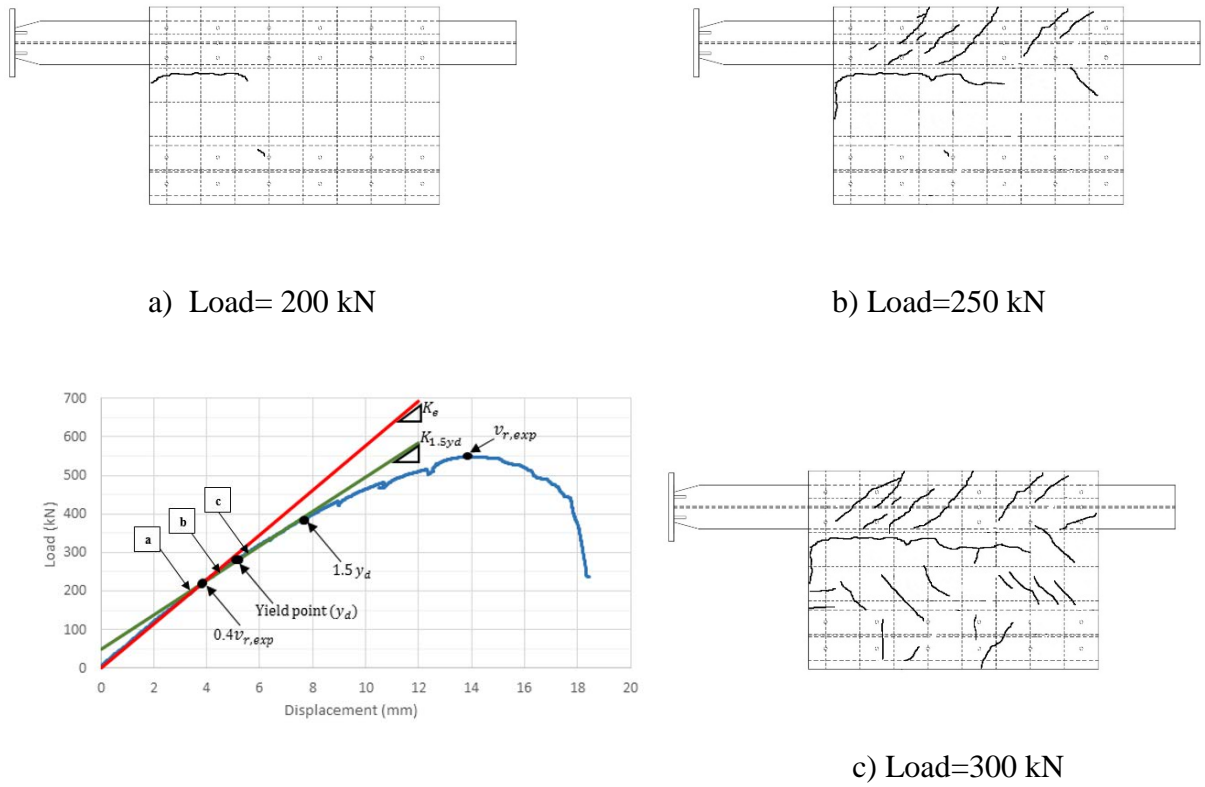
Figure 13. Stiffness reduction, Sp1

The stiffness of a diaphragm system is of paramount importance for seismic design. Degradation of stiffness can adversely affect the response and behaviour of the structures against severe earthquakes and should be considered in the early stages of design. Basically, Diaphragms are designed to behave elastically and remain in the elastic range during severe earthquakes. The elastic stiffness values for all specimens are calculated by the secant stiffness through a point corresponding to 40% of the ultimate shear strength ( $V_{r,exp}$ ).

Diaphragm stiffness was determined at the displacement equal to 1.5 times yield point displacement as well and reported in Table 2. Results revealed that stiffness reduction of three specimens were gradual and even beyond yield point they had considerable stiffness. All easily meet the stiffness requirements from NZS 1170.5 for a rigid diaphragm in the elastic range.

Given that the force-displacement relation may not have a well-defined yield point, the definition of yield displacement exhibits some complexities and several methods have been proposed by researches in the literature [13]. Choosing a suitable method is dependent on the structural behaviour and material properties. The yielding point could be defined based on the test observations and also the load-displacement curve obtained from testing, where the elastic stiffness of specimen changes significantly. Herein yielding point is determined as a point where the diagonal cracks initiated in the specimen which agrees well with the load-displacement curve where its gradient changed obviously, showing the decrease of shear stiffness. Fig. 13 shows load-displacement, yielding point, stiffness and crack propagation at different steps for Sp1. It could be seen that most of cracks propagated over 6<sup>th</sup> step of loading (250 kN-300 kN) which shows a good agreement with the load-displacement curve where the slope of tangent line (red line), showing elastic shear stiffness ( $K_e$ ) and the actual load-displacement curve began separating at 280 kN approximately. Consequently, this point could be considered as the yielding point. The corresponding displacement for this load (280kN) is 5.1 mm. As it seen from Fig. 13, the stiffness reduction is quite slow and even for the displacement equal to 1.5 times the yield point displacement; the stiffness lost only less than 25% of its elastic stiffness. In this figure, the slope of green tangent line represents the stiffness at that point. The stiffness reduction percentage for Sp2 and Sp 3 was 35% and 50% respectively. Results for all three specimens are presented in Table 3.

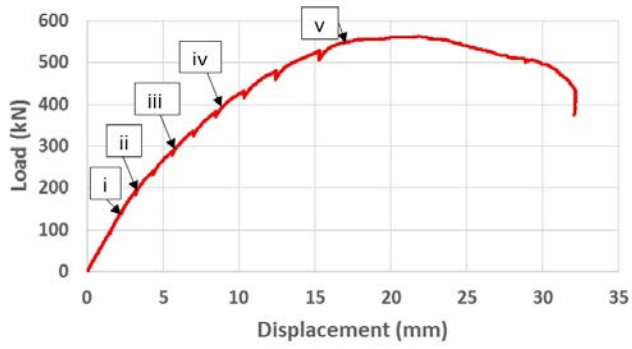
b) Sp2

Figure 14. Cracking pattern at different stages of loading

For the second and third specimens, diagonal cracks spread across the slabs with the distinction that for the second one more cracks concentrated near the loading beam, whereas for the third one more cracks produced around the reaction beam compared to the second specimen. The second specimen experienced its first two cracks during the fourth step of loading (150-200 kN). These cracks were around 0.1mm wide. The crack width became 0.2mm at 350 kN, and increased to 0.5mm at 500 kN (see Fig. 14b).

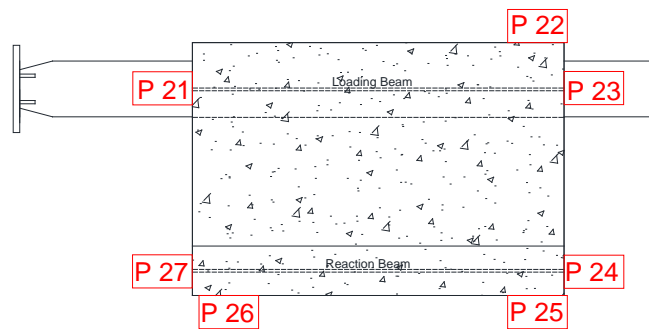
Figure 16. Position of displacement gauges

Fig. 16 shows the position of the displacement gauges. Seven displacement gauges were installed between the steel beams and composite slab at the four corners to measure relative longitudinal and transverse slippage between the composite slab and steel beams.

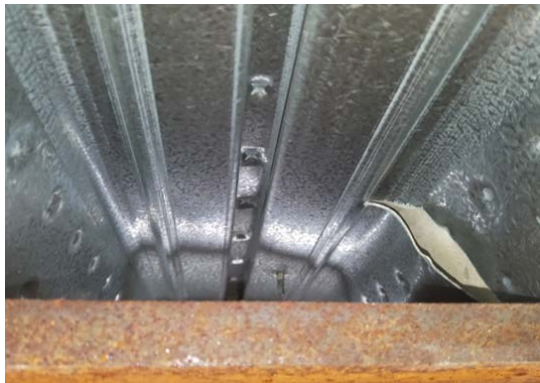
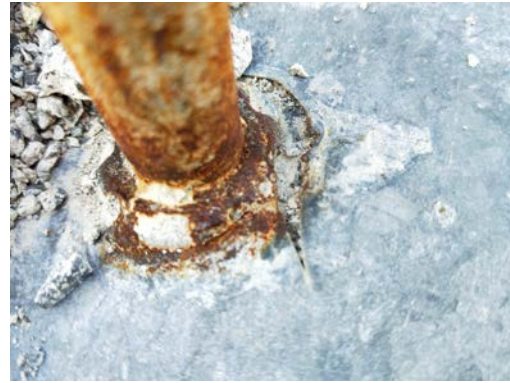
a) Sp2

b) Sp3

Figure 21. Tearing of steel deck

However, tearing of steel deck was observed in Sp2 and Sp3 with multiple shear studs in a rib (see Fig. 21).

Tears in Sp2 were long and easily could be seen from below, while in Sp3 they were quite short and were not visible unless the concert was removed. Fig. 21b shows that punching and tearing of steel sheet happened in front of the stud due to load transferring from the shear stud to the steel deck.

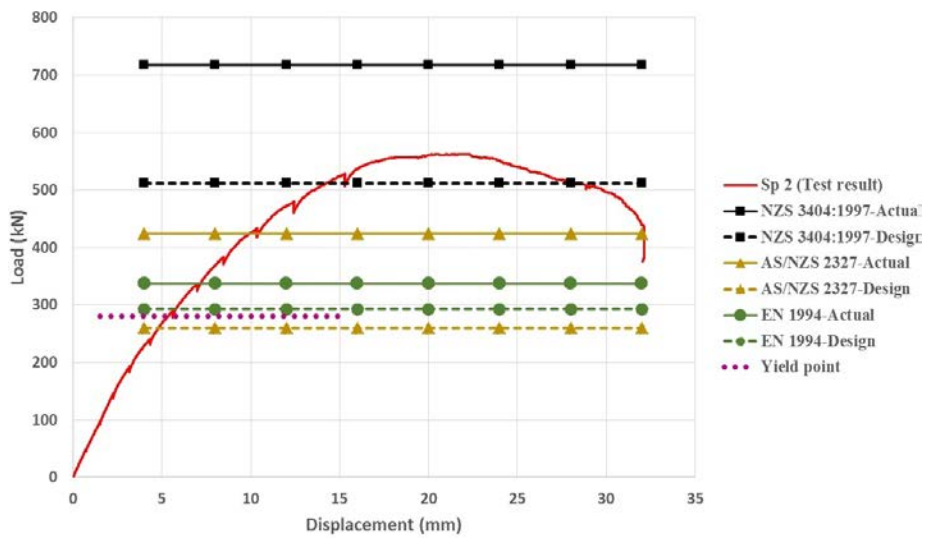
Figure 23. Test results and codified equations a) Sp1, b) Sp2, c) Sp3

As can be seen from Table 4, the experimentally recorded ultimate shear strength of all three specimens were similar. However, both AS/NZS 2327:2017[22] and EN 1994-1-1:2004 [23] predict a much higher shear strength for Sp3 which uses the European detail. This revealed that contribution of the steel deck and shear studs to the diaphragm interface shear capacity is negligible, compared with the significant contribution predicted by these equations.

The Easterling and Porter equation considers the influence of the steel deck by converting the steel thickness to an equivalent concrete thickness. However, it leads to a conservative predicting for the ultimate shear strength. The equation does not include the influence of the edge rebar, which all the other equations have done. The authors have proposed that by adding on the influence of the edge rebars a better prediction can be obtained.
