APPENDIX B

Map series 1 - Overview maps			
Map 1.1	General overview map		29
Map 1.2	Overview map - Northern suburbs		30
Map 1.3	Overview map - Central suburbs		31
Map 1.4	Overview map - Eastern suburbs		32
Map 1.5	Overview map - Southern suburbs		33
Map 1.6	Overview map - Port Hills and Lyttelton suburbs		34
Map series 2 - Northern suburbs			
Map 2a	General land observation map	Total area of liquefaction observations to 13 June 2011	35
Map 2b	Detailed land observation map	Recorded observations from 4 September 2010	36
Map 2c	Detailed land observation map	Recorded observations from 22 February 2011	37
Map 2d	Observed ground cracking	Crack locations post 4 September 2010 and 22 February 2011	38
Map 2e	Groundwater elevation contours		39
Map 2f	LiDAR survey	Bare earth digital elevation model pre September 2010	40
Map 2g	LiDAR survey	Bare earth digital elevation model post June 2011	41
Map 2h	Ground surface elevation change	LiDAR difference pre 2010 to post June 2011	42

MAP SERIES 5
GENERAL LAND OBSERVATION MAP
Total Area of Liquefaction Observations from Events
Between 4 September 2010 to end 13 June 2011

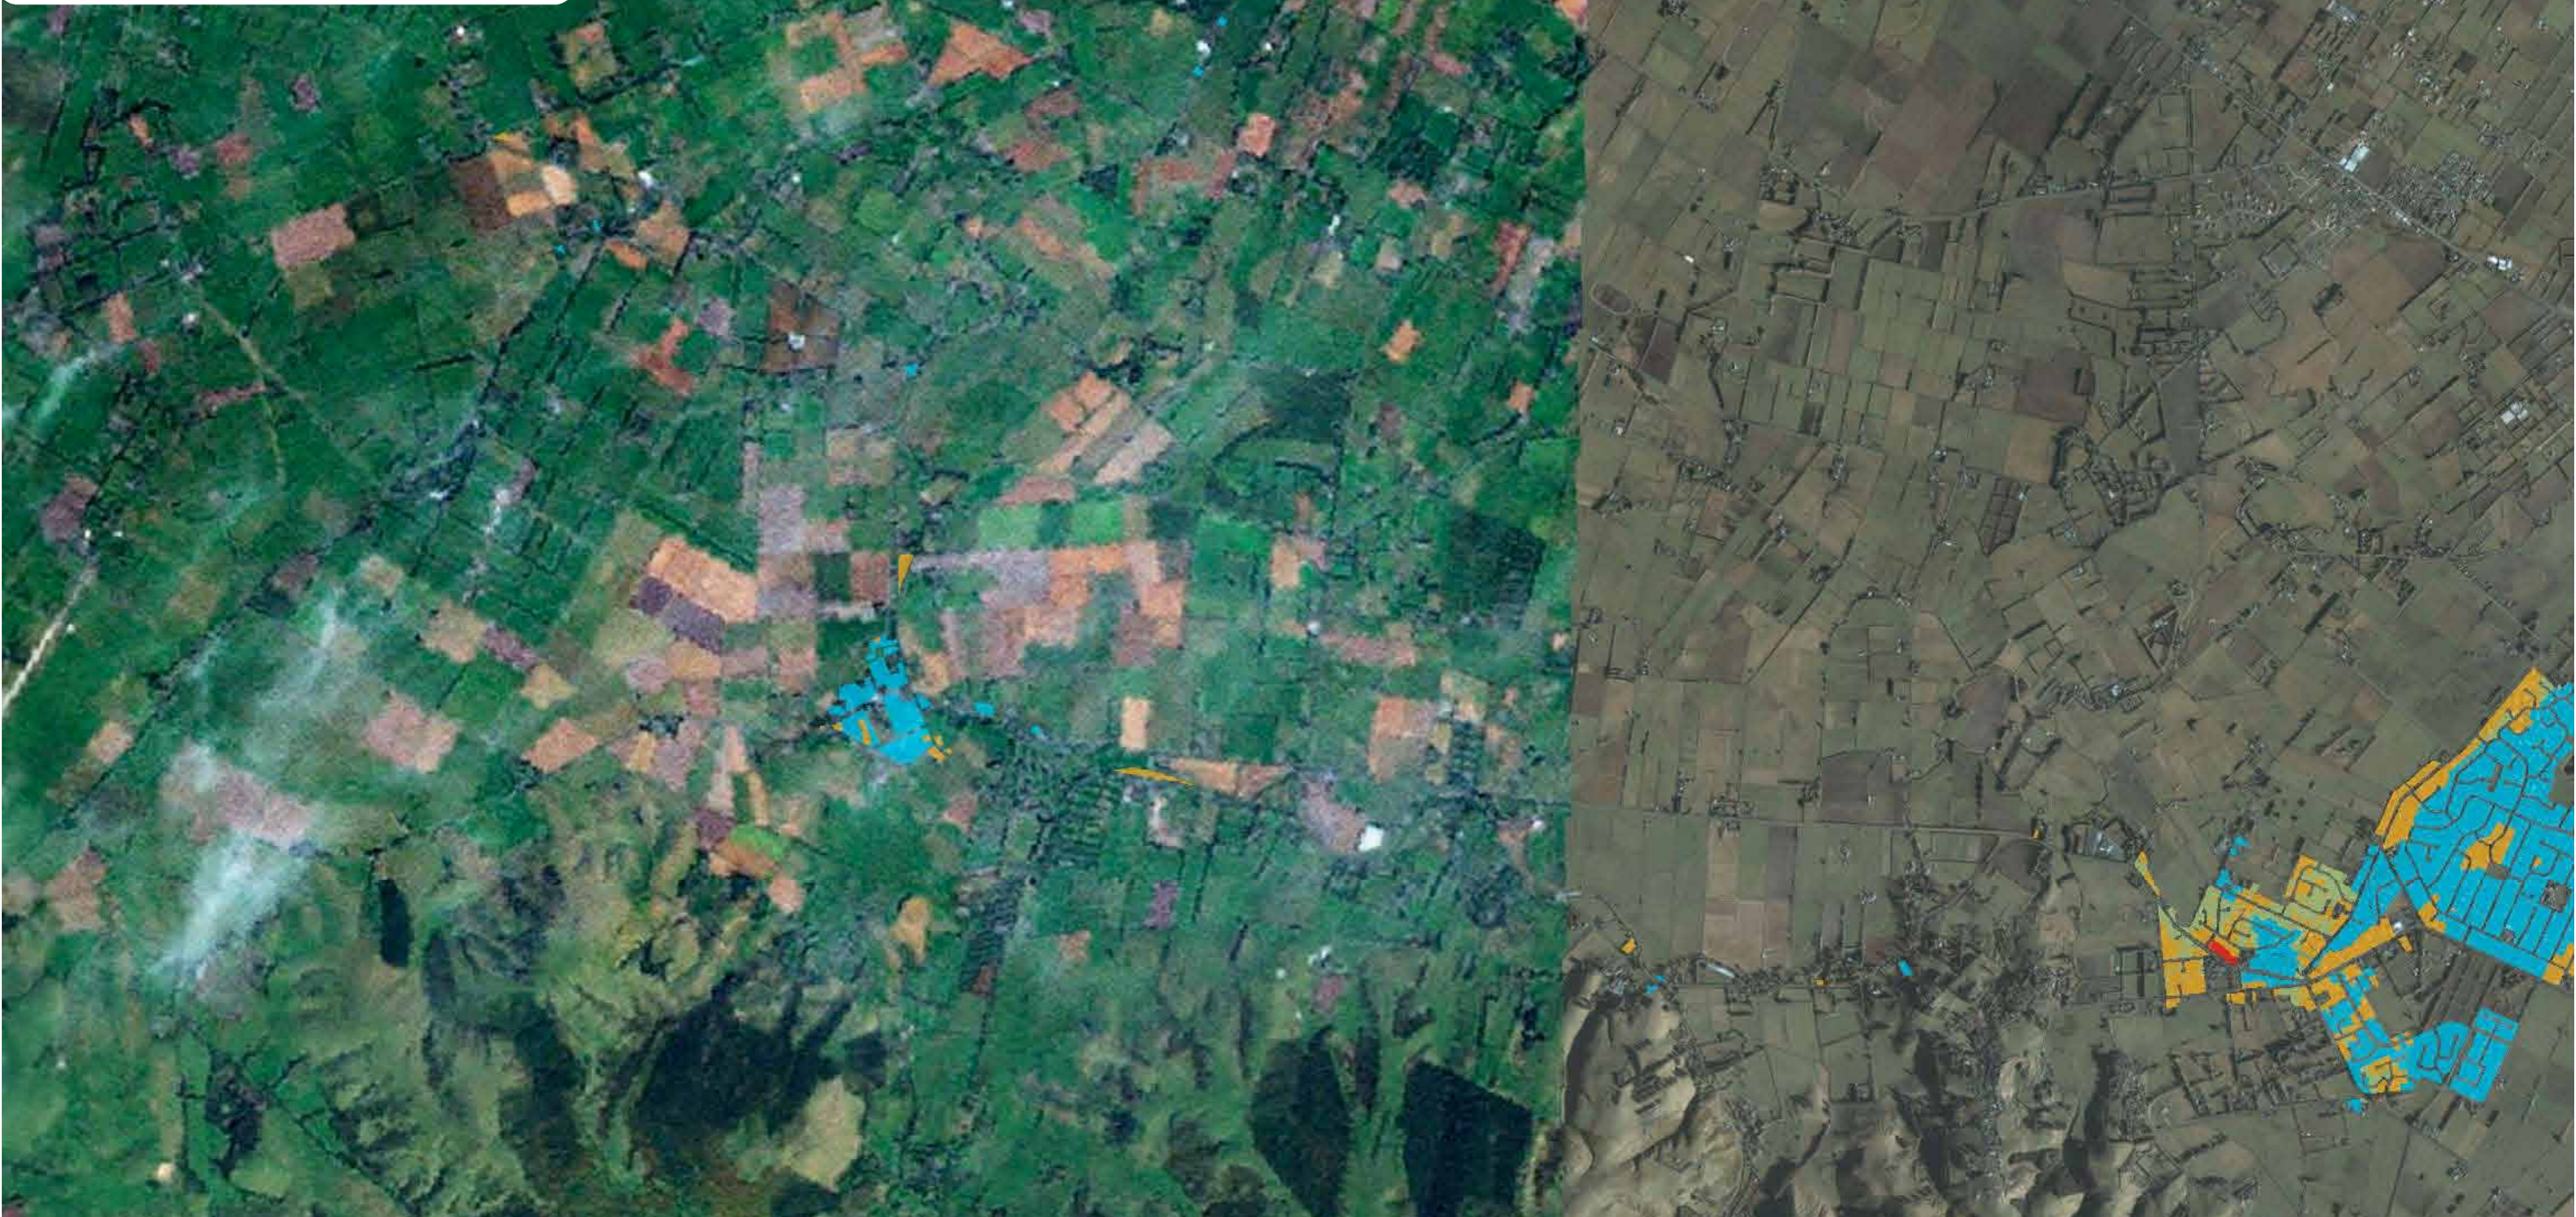
FIGURE No. Map 5b Southern Suburbs

- No observed ground cracking or ejected liquefied material
- Minor ground cracking but no observed ejected liquefied material
- No lateral spreading but minor to moderate quantities of ejected material
- Moderate to major lateral spreading or large quantities of ejected material
- Severe lateral spreading; ejected material often observed

DETAILED LAND OBSERVATION MAP

Recorded Liquefaction and Lateral Spreading Observations from 4 September 2010
