AS-BUILT DAMAGE SKETCH

EQC
EARTHQUAKE COMMISSION
Kōmihana Rūwhenua

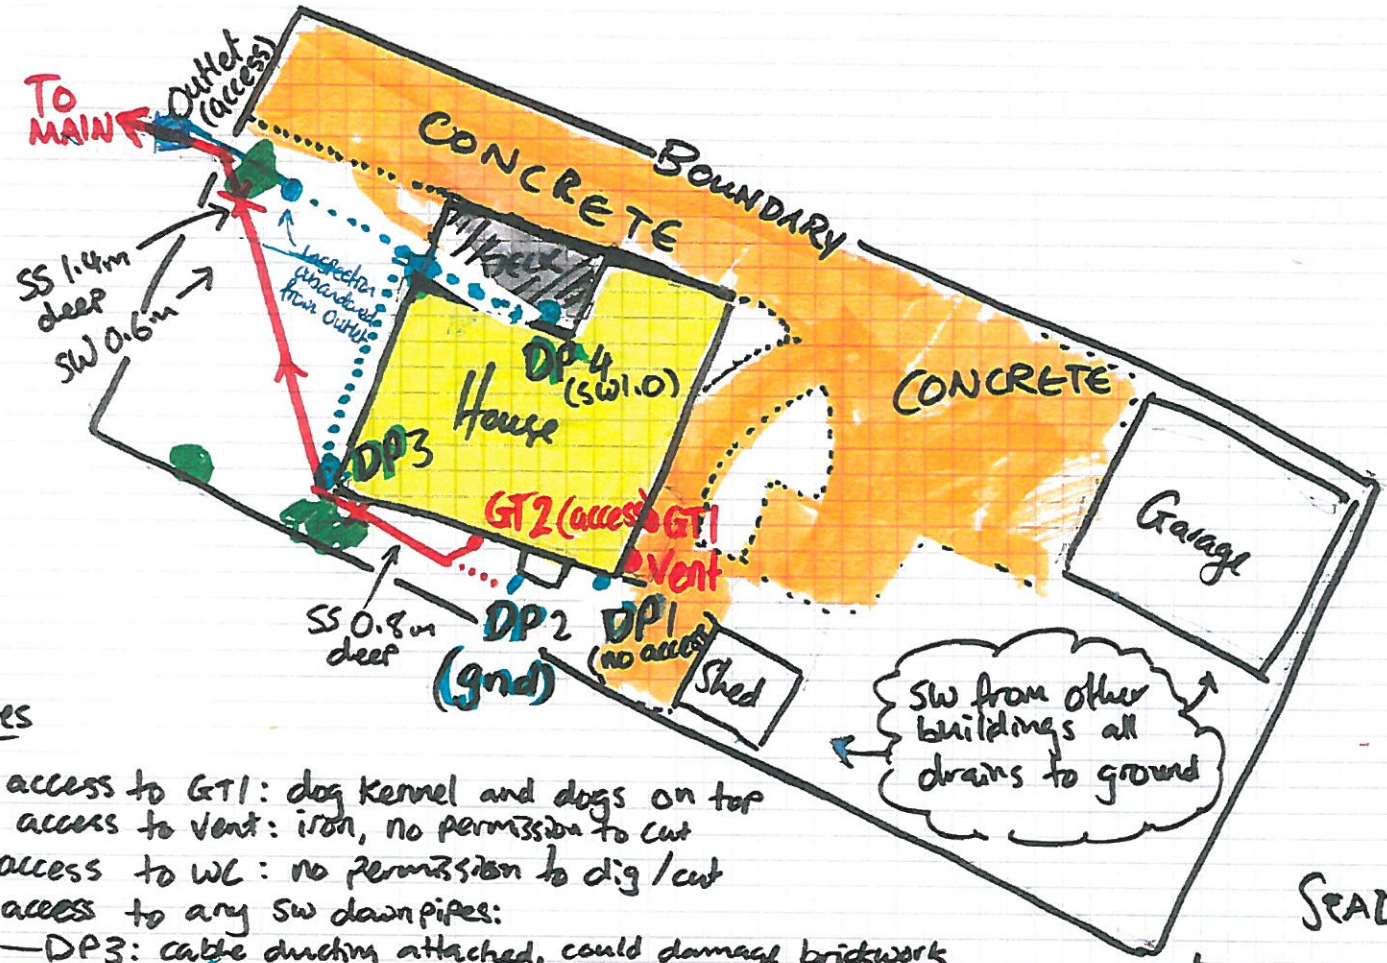
- no access to GT1: dog kennel and dogs on top
- no access to Vent: iron, no permission to cut
- no access to WC: no permission to dig / cut
- no access to any SW downpipes:
  - DP3: cable ducting attached, could damage brickwork
  - DP1: cemented, no permission to cut
  - DP4: under wooden deck
- access to part of SW line from outlet, but abandoned due to massive RI
