ENG
380

Guidance on house repairs and reconstruction following the Canterbury earthquake

**A summary of geotechnical and structural
engineering recommendations to guide
house repairs and reconstruction**

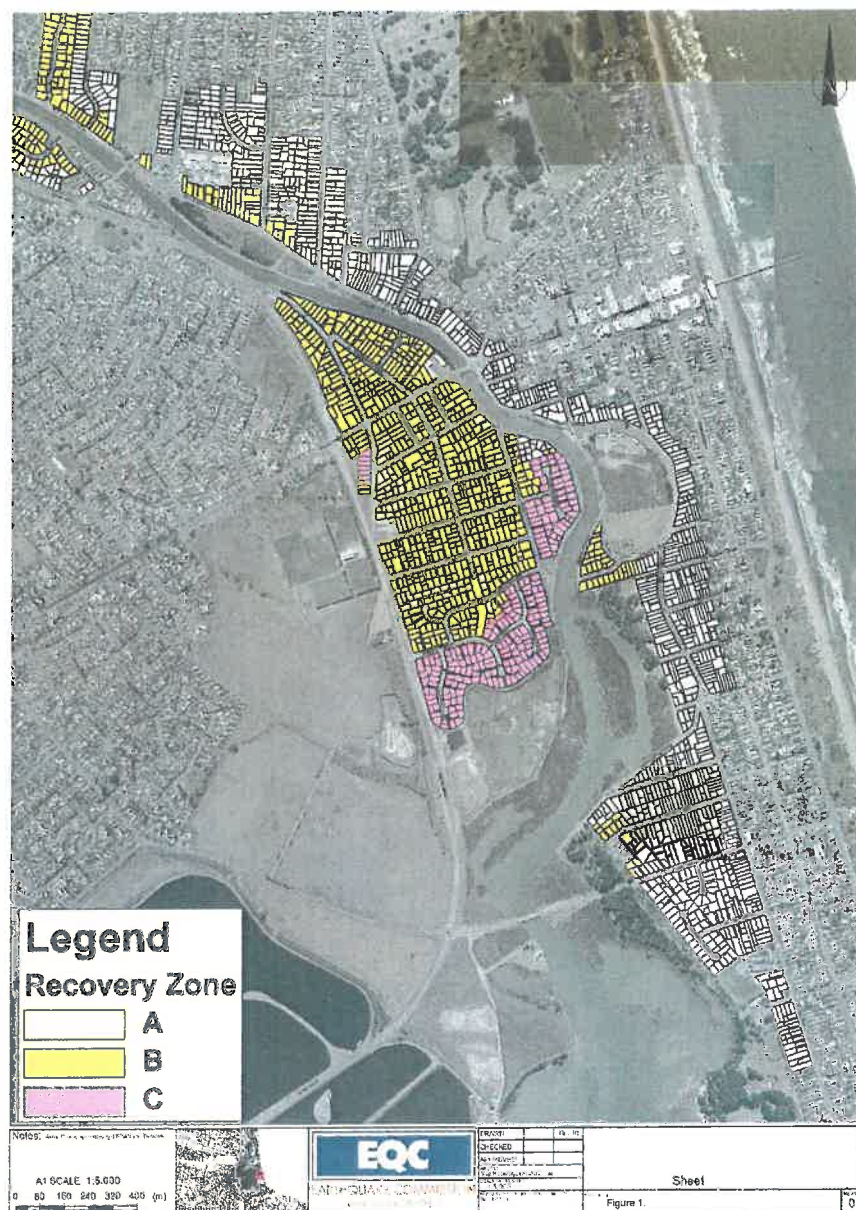
Figure 3.3: Example of Bexley Recovery Zone map

An example representation of the land recovery zoning is shown in Figure 3.3.

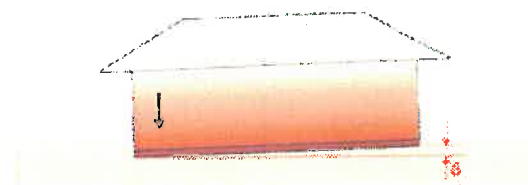
Tilt settlement

With tilt settlement, the whole foundation tilts as a rigid body.

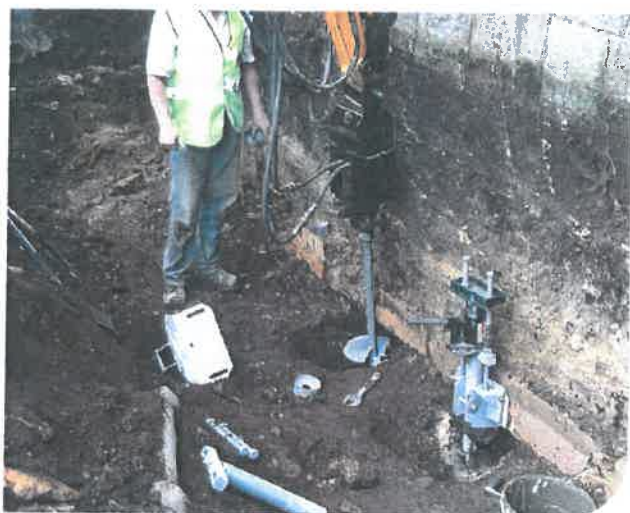
- Lifting Option 2: Perimeter foundation jacking using piles (screw or similar)

Foundation re-levelling using screw piles involves installing piles at discrete locations to the perimeter of the foundation wall, and installing under-beam shoes fitted with jacks to raise the foundation to the correct level. With the foundation repositioned, flowable grout is introduced to the cavity created under the raised foundation. Once the grout is cured the jacks are removed, and the screw piles removed. The screw piles may also be used as a permanent support.

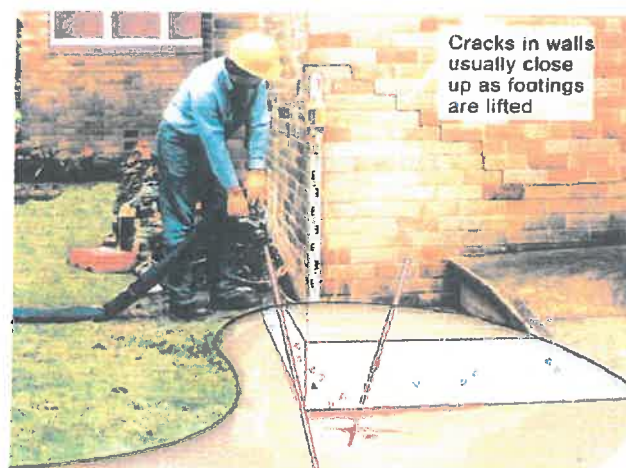
- Lifting Option 3: Perimeter foundation jacking using engineered resin

This option is a proprietary lifting process where engineered resin is injected into the ground at multiple points along the foundation. The expanding resin lifts the foundation. The process also densifies the surrounding ground which serves as a reaction layer for the lifting operation.

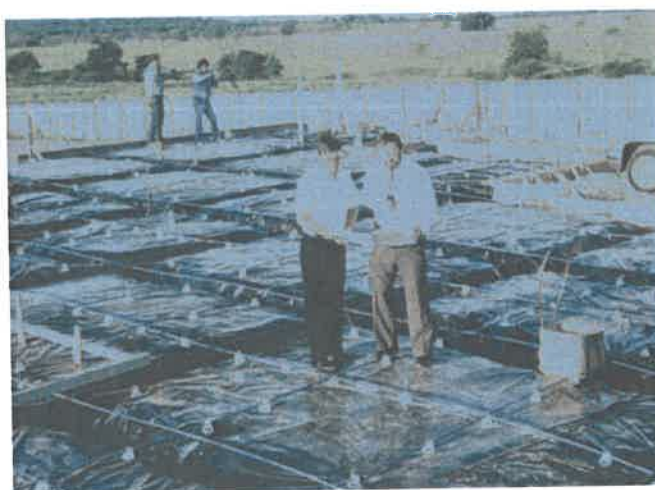
Example foundation plan

Option 4 – Construct a stiffened waffle slab over the existing soil.

Section B - B

Note: DPC omitted for clarity
