Christchurch Earthquake Recovery
Geotechnical Factual Report
Opawa
Appendix E:
Laboratory Testing

Appendix E: Laboratory Test Results

CHRISTCHURCH 2011 EARTHQUAKE REMEDIATION	
LABORATORY TEST RESULTS	
LOCATION: Opawa	BOREHOLE: BH-OPA-01

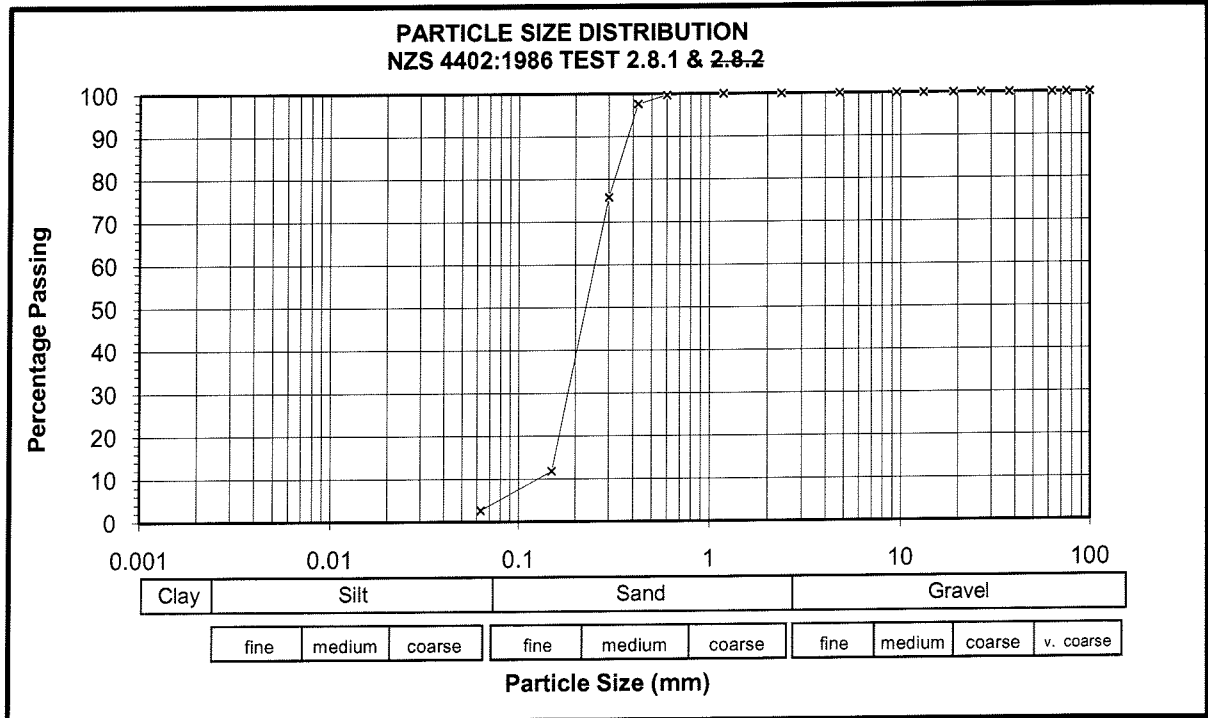
Sample Number: BH-OPA-01 PSDWS-11.5

Material: Fine to medium SAND, grey. Moist, poorly graded.

Depth: 11.5m

Sieve Aperture (mm)	Cumulative % Passing
200.0	100
150.0	100
100.0	100
75.0	100
63.0	100
37.5	100
26.5	100
19.0	100
13.2	100

Sieve Aperture (mm)	Cumulative % Passing
9.5	100
4.75	100
2.36	100
1.18	100
0.60	100
0.425	98
0.30	76
0.15	12
0.063	3

SAMPLE NO	TEST RESULTS		
	PSD	FINES CONTENT %	WATER CONTENT %
FC-8.3	N/A	13.69	20.1
FC-11.0	N/A	17.81	27.9
PSDWS-11.5	GRAPH ATTACHED	2.56	25.9
FC-14.7*	N/A	10.66	24.8
FC-15.4	N/A	21.74	18.0
FC-19.0	N/A	7.56	25.4

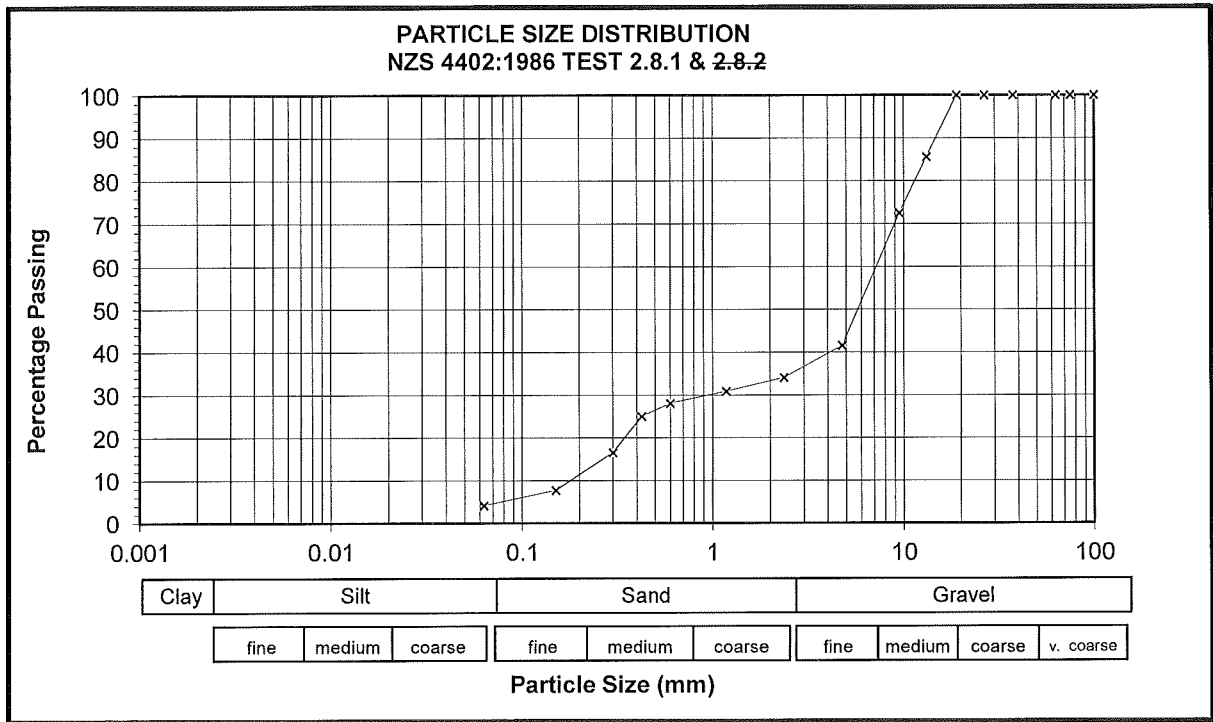
Sample Number: EQLABOpawa/131011/PSDWS-2.7 Depth: 2.7m

Material: Sandy, fine to coarse GRAVEL, dark grey. Medium dense, wet. Sand is fine to coarse.

Sieve Aperture (mm)	Cumulative % Passing
200.0	100
150.0	100
100.0	100
75.0	100
63.0	100
37.5	100
26.5	100
19.0	100
13.2	86

Sieve Aperture (mm)	Cumulative % Passing
9.5	73
4.75	42
2.36	34
1.18	31
0.60	28
0.425	25
0.30	17
0.15	8
0.063	4

SAMPLE NO	TEST RESULTS		
	PSD	FINES CONTENT %	WATER CONTENT %
PSDWS-2.7	GRAPH ATTACHED	4.02	5.3
PSDWS-3.8	GRAPH ATTACHED	1.49	6.6
FC -5.5	N/A	1.45	21.2
PSDWS-6.5	GRAPH ATTACHED	1.54	3.0
FC-7.7	N/A	84.71	17.6

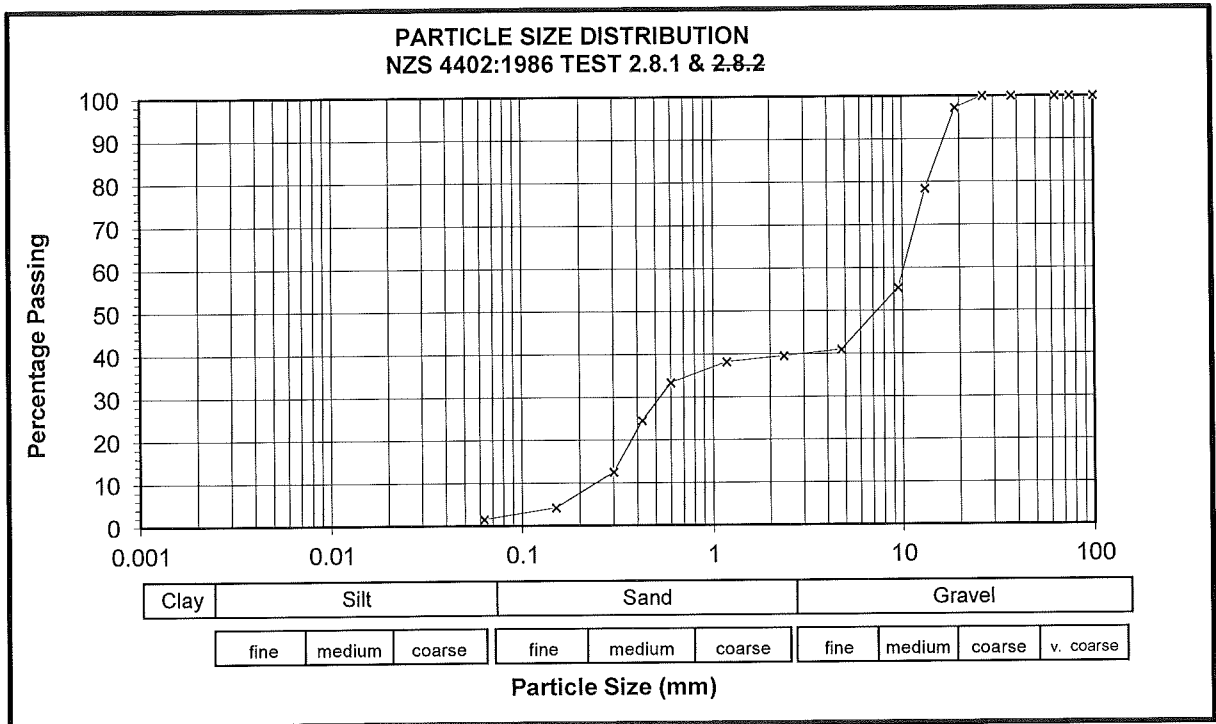
Sample Number: EQLABOpawa/131011/PSDWS-3.8 Depth: 3.8m

Material: Sandy, fine to coarse GRAVEL, dark grey. Medium dense, wet. Sand is fine to coarse.

Sieve Aperture (mm)	Cumulative % Passing
200.0	100
150.0	100
100.0	100
75.0	100
63.0	100
37.5	100
26.5	100
19.0	97
13.2	78

Sieve Aperture (mm)	Cumulative % Passing
9.5	55
4.75	41
2.36	40
1.18	38
0.60	33
0.425	25
0.30	13
0.15	4
0.063	2

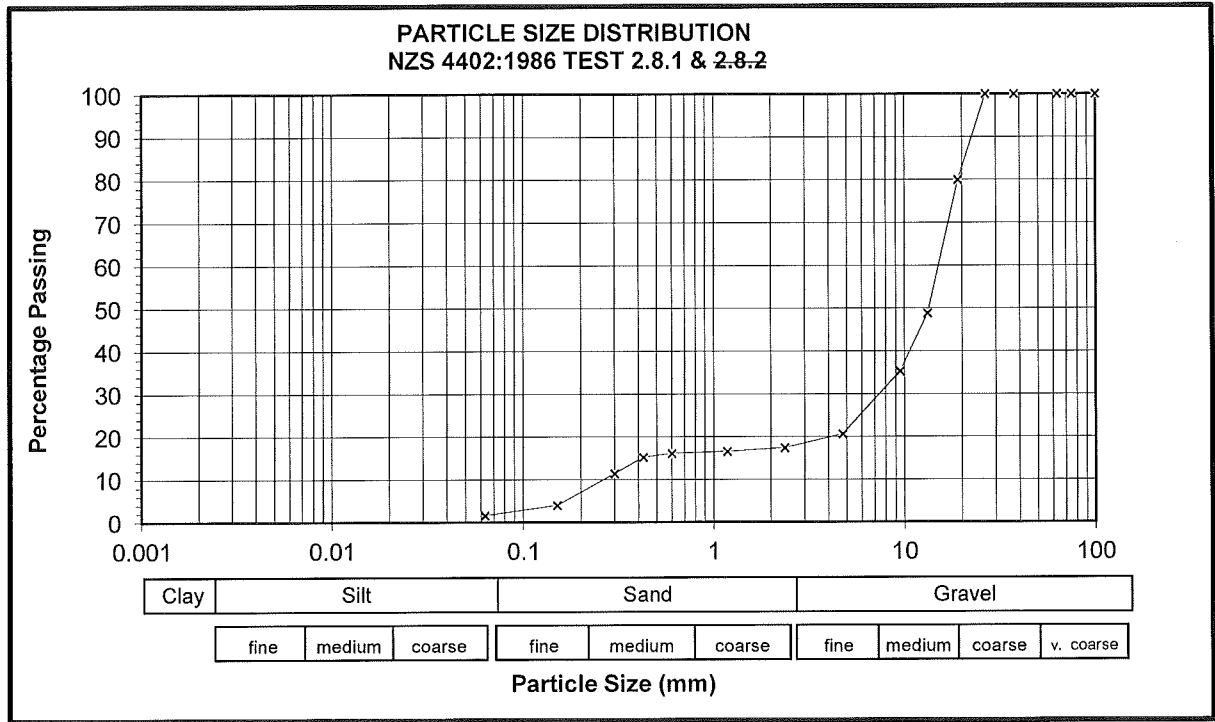
Sample Number: EQLABOpawa/131011/PSDWS-6.5 Depth: 6.5m

Sieve Aperture (mm)	Cumulative % Passing
200.0	100
150.0	100
100.0	100
75.0	100
63.0	100
37.5	100
26.5	100
19.0	80
13.2	49

Sieve Aperture (mm)	Cumulative % Passing
9.5	35
4.75	21
2.36	17
1.18	17
0.60	16
0.425	15
0.30	11
0.15	4
0.063	2
