<b>Project:</b> Christchurch 2011 Earthquake - EQC Ground Investigations			<b>Page:</b> 1 of 2	<b>CPT-OPA-05</b>	
<b>Test Date:</b> 17-May-2011	<b>Location:</b>		<b>Operator:</b>		
<b>Pre-Drill:</b> 1.2m	<b>Assumed GWL:</b> 4.5mBGL		<b>Located By:</b> Survey GPS

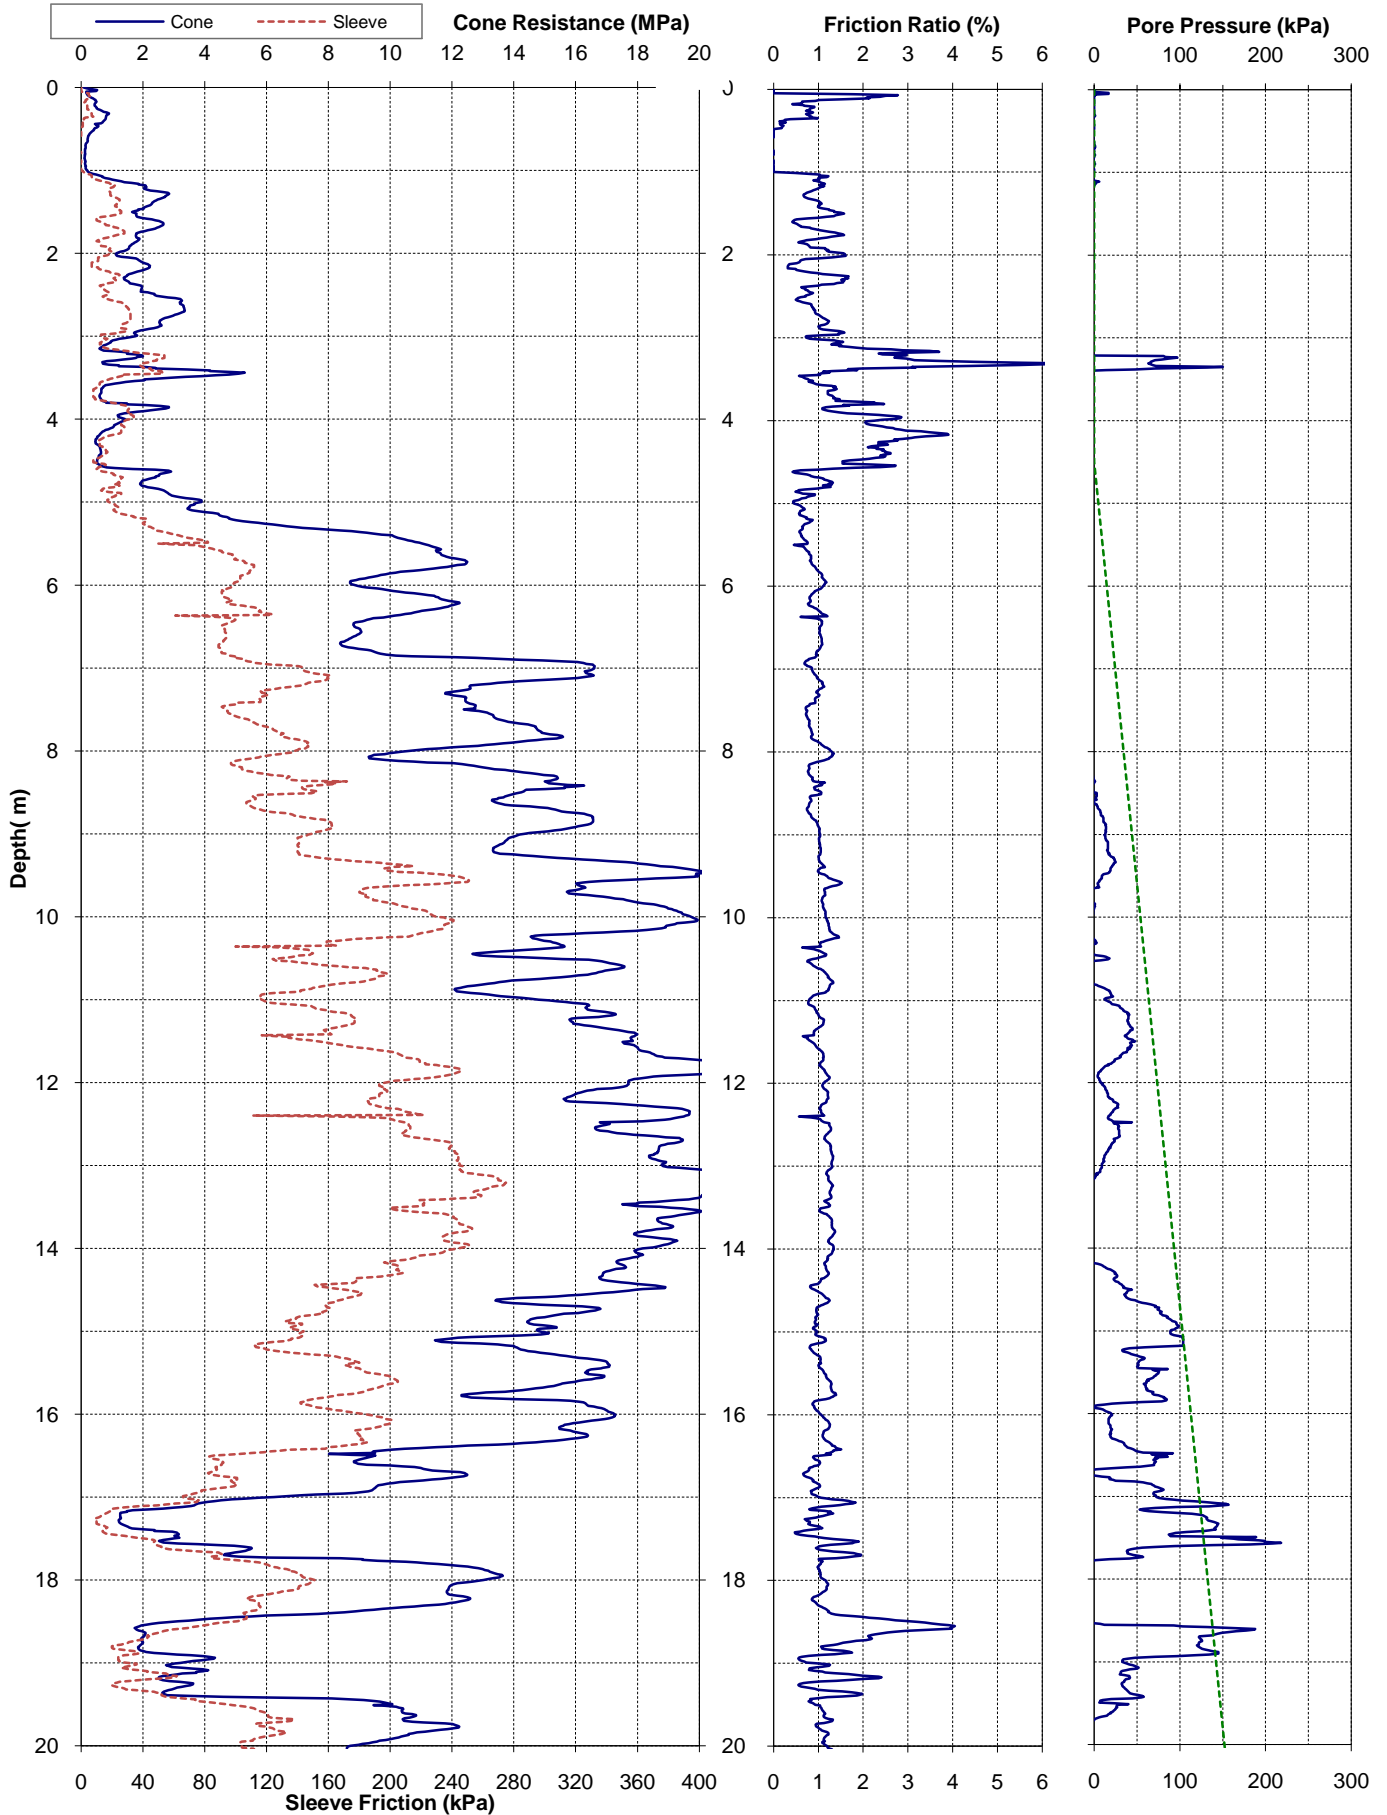
<b>Position:</b> 2482663.9mE 5739523.9mN 4.726mRL	<b>Coord. System:</b> NZMG & MSL		<b>Comments:</b>		
<b>Other Tests:</b>

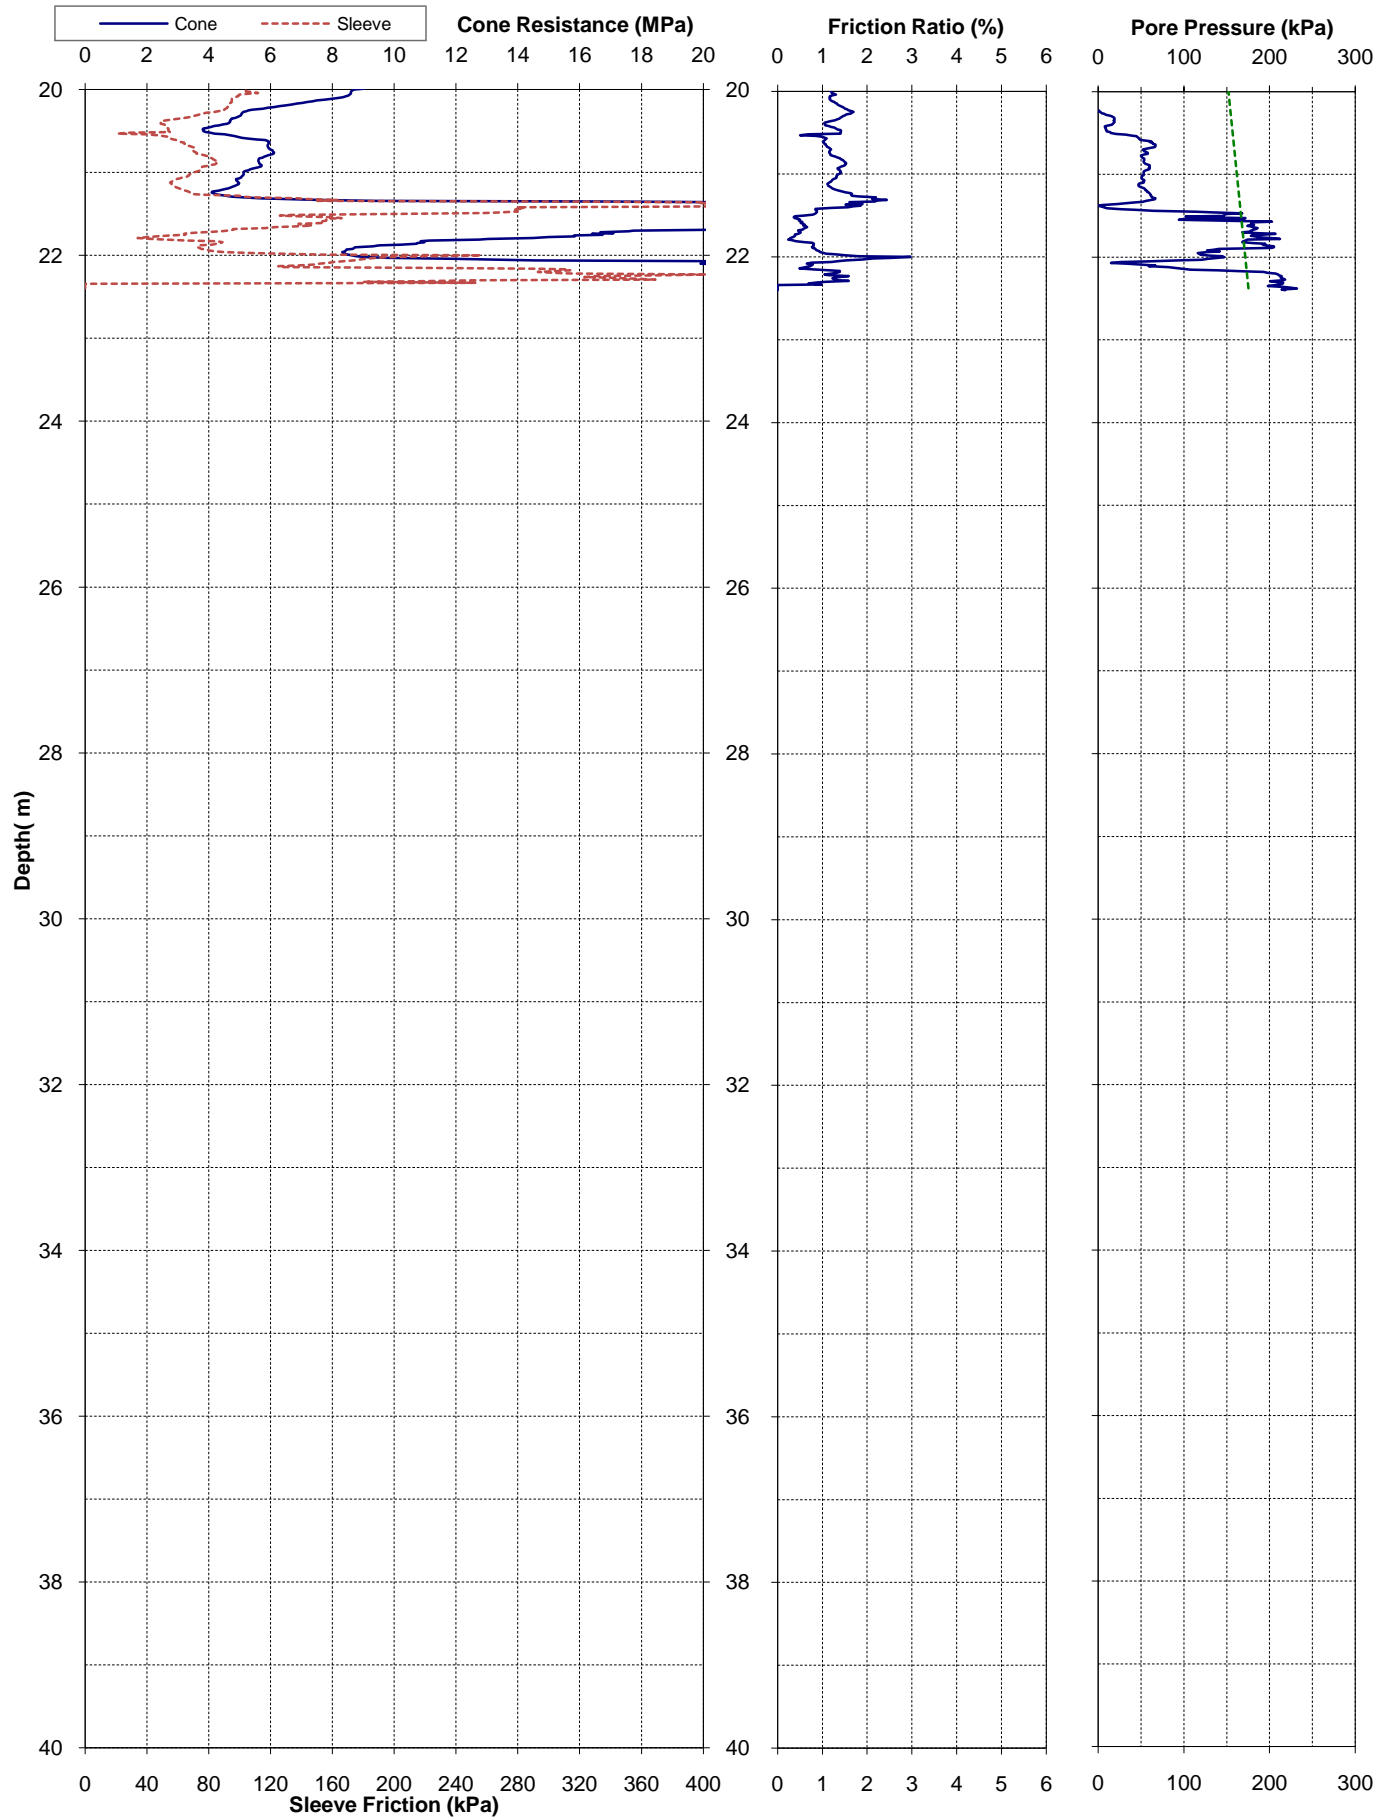
<b>Project:</b> Christchurch 2011 Earthquake - EQC Ground Investigations			<b>Page:</b> 2 of 2	<b>CPT-OPA-05</b>	
<b>Test Date:</b> 17-May-2011	<b>Location:</b>		<b>Operator:</b>		
<b>Pre-Drill:</b> 1.2m	<b>Assumed GWL:</b> 4.5mBGL		<b>Located By:</b> Survey GPS

<b>Position:</b> 2482663.9mE 5739523.9mN 4.726mRL	<b>Coord. System:</b> NZMG & MSL		<b>Comments:</b>		
<b>Other Tests:</b>
